Study of Techno-Legal Aspects of Accident Site Investigation—A Case Study from Bengaluru

Ashish Verma, P. Anbazhagan, and R. Babitha

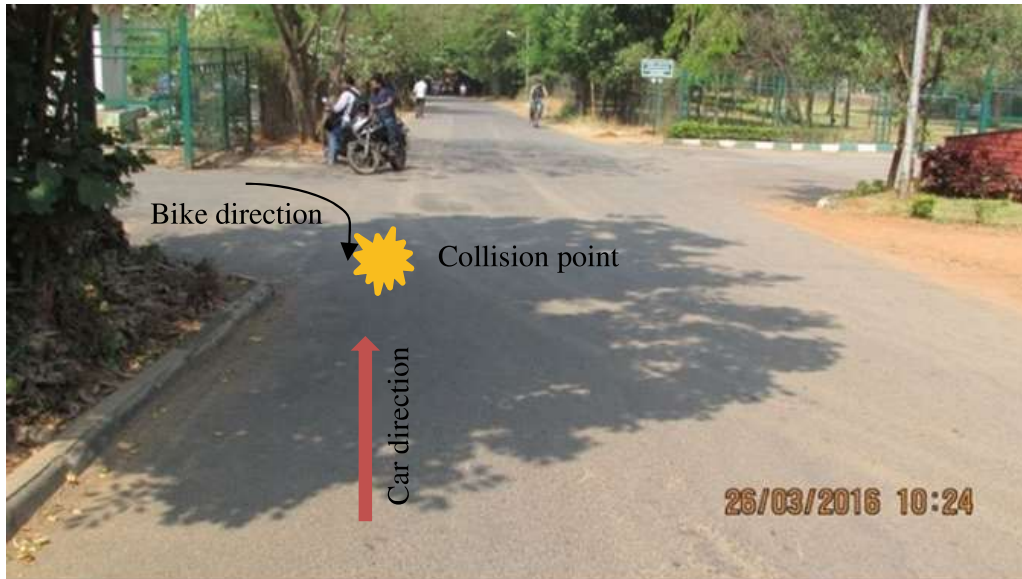
Fig. 2 Show view of the road from car direction (toward D-gate) with blind zone at the left of car due to fencing vegetation

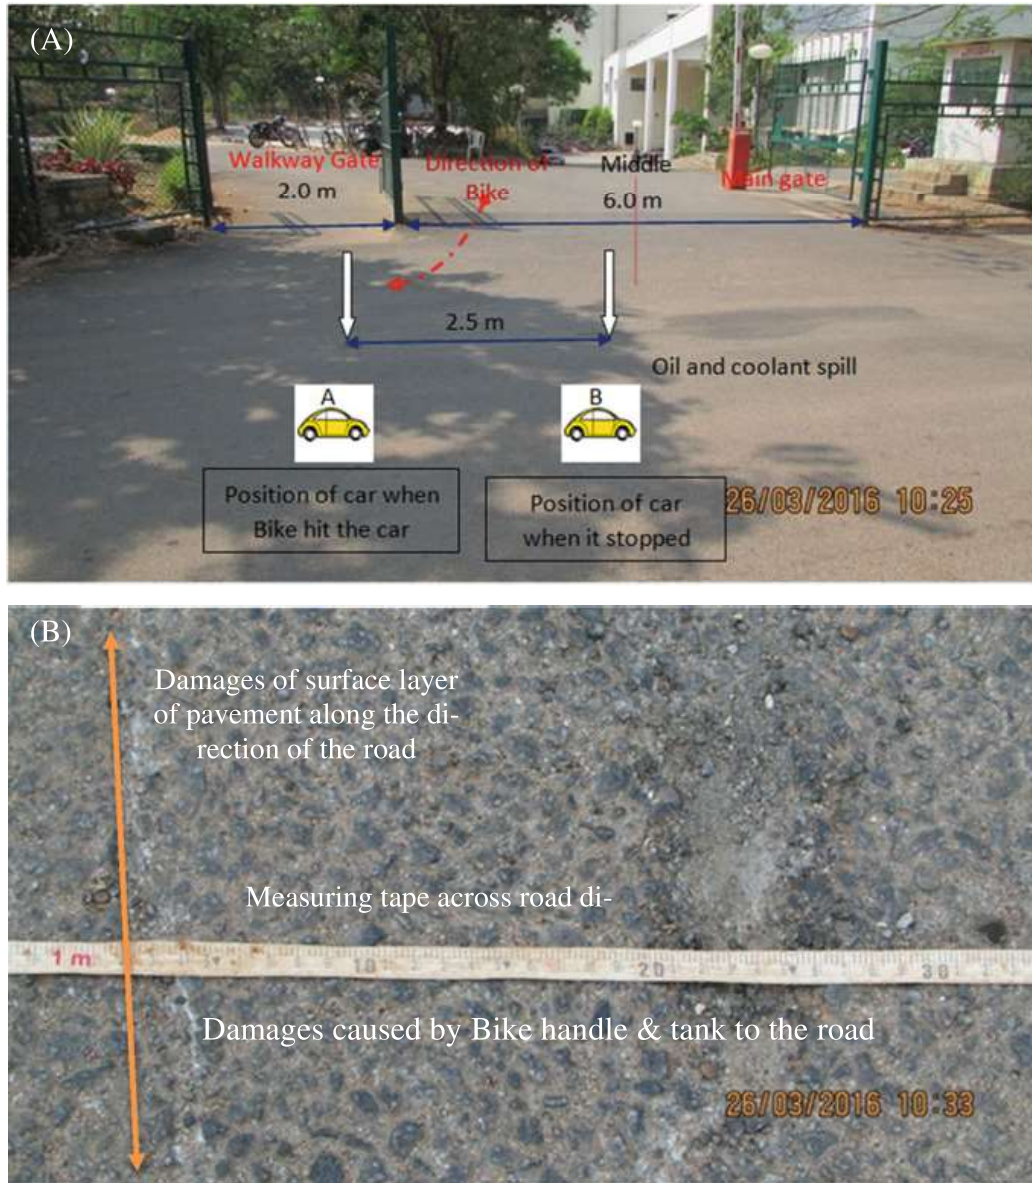
Fig. 3 a Crash spot with the marking of the initial position of the car at the time when the bike hit the car, final position where the car was stopped, gates and stopping distance marking and oil spill on the road. b Closer view of structural damage of road due to hitting bike handles and distance from the edge of the road (the left side toward D-Gate)

The authors personally visited the site and tried to understand the crash in technical detail before concluding the crash. The crash spot was studied, and data collected from the site are compiled to prepare the schematic location and vehicle position. Figure 3a shows the crash spot with information collected from the geometrical parameters. It was found that car was moving on the left side of the main road, and the bike was coming from the approach road to the main road. Crash spot was studied, and ground evidence was collected like soil, coolant spill location, and road damages caused by vehicles. The total width of the main road is 6.4 m, and damages on the road due to bike handle and tank hitting bitumen surface (Fig. 3b shows road damage with measurement) was noticed within 1.2 m from the left edge of the road. It indicates that during and after the crash, both vehicles are within the left lane of the main road. By tracing the beginning to end line of road damage along the left lane point of the road damage, we could arrive at the distance traveled by both vehicles after collision (initial damage location by bike handle) up to the halt position (final position where oil and coolant spill starting point and end of handle damage in the road). The bike left handle created an impression in the bituminous road surface up to 3.8 m followed by a patch mark on the road surface due to leakage of oil and coolant, which is the endpoint of the crash. Figure 3a shows the photos of road with bike handle impression, walkway gate, and main gate with oil and coolant spill on the road surface. Initial position at the time of the crash and the final position of the car after stopping are marked in Fig. 3a as A and B; we measured the distance between these two points as 3.8 m along the main road and 1.2 m from the left edge of the main road. Other geometric data are collected and marked in the crash spot photo in Fig. 3a. The position and direction of vehicles at the time of the crash and after both vehicles were halted were mapped. It can be clearly noted that there is a violation of traffic rules by bike driver, instead of exiting at the left lane of the approach road; bike exited at the right lane of the approach road, which is a violation of traffic as per Indian Traffic rules.

- The crash occurred about 1.2 m from the left edge of the main road in the left lane toward D Gate.
- Both car and bike were in motion at the time of the collision, which happened in front of the walkway in the left lane toward D gate fencing.
- After falling, the bike's left handle caused structural damage to a road opposite to walkway entry.
- No car wheel impression on the main road was observed, which mean that car has not applied sudden brake in high-speed.

In this study, structural damage to the road (impression and mark in Fig. 3a) caused by a bike can be taken as the initial point of crash, and the origin of oil and coolant leakage can be taken as the final vehicle position, i.e., halt of vehicles after the crash. Location of car after the crash, i.e., stopped position also confirmed with driver of car and eye witness on the spot, i.e., security person. There is no video recording in this location of the campus. Physical measurement in the accident spot of the initial and final position of the car was measured and found to be 3.8 m, as shown in Fig. 3a. The stopping distance or distance within a motor vehicle can be a function of (a) total reaction time of the driver, (b) speed of vehicle, (c) efficiency of brakes, (d) frictional resistance between the road, and (e) the tyres and gradient of the road. In this case, we have a stopping distance measurement of 3.8 m, which can be used to estimate the speed of the vehicle, and other parameters can be taken based on the accident spot. Indian Road Congress highlighted that the total reaction time of a good driver is 2.5 s. Based on this, the speed of car (km/h) can be calculated by the formula given below as per Khanna and Justo [11].

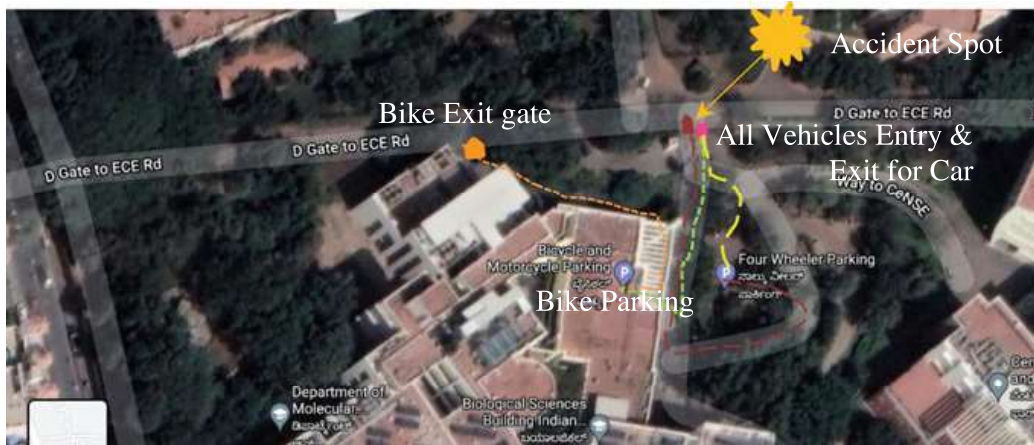
The two-wheeler parking area entry and exit in approach road were also studied, and a Google Maps is shown in Fig. 4. Considering blind spot for a vehicle toward D Gate, the campus had separate parking and exit for two-wheelers as shown in Fig. 4.

Considering parking for two-wheelers and exit location, it is very clear that the bike should have come out on the main road from the dedicated exit gate for a two-wheeler to avoid blind spot and 90° turning at approach road in Fig. 3b.

Fig. 4 Crash spot in Google Maps with entry and exit arrangement made as per traffic rules

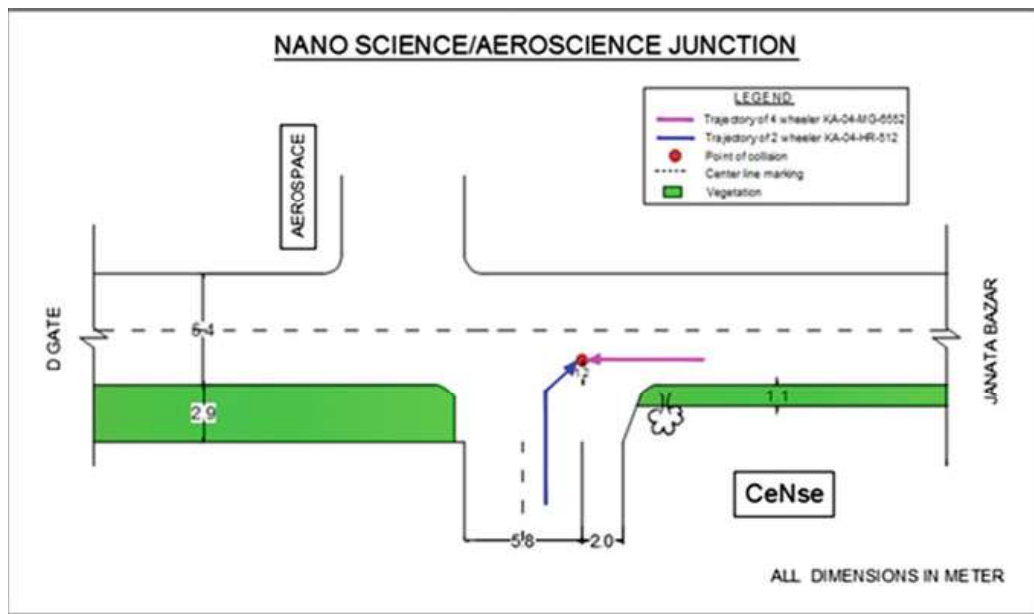
As explained above and also as per the crash location marking, the bike was taking a right turn in the left lane towards the main road instead of taking a safe exit gate, which may be due to the bike driver is not familiar with campus and these traffic regulations, as he is not campus user or resident. Figure 5 presents the condition and

Fig. 5 Condition and collision diagram of the crash location

collision diagram of the crash prepared to explain the same after sufficient evidence and study discussed above.

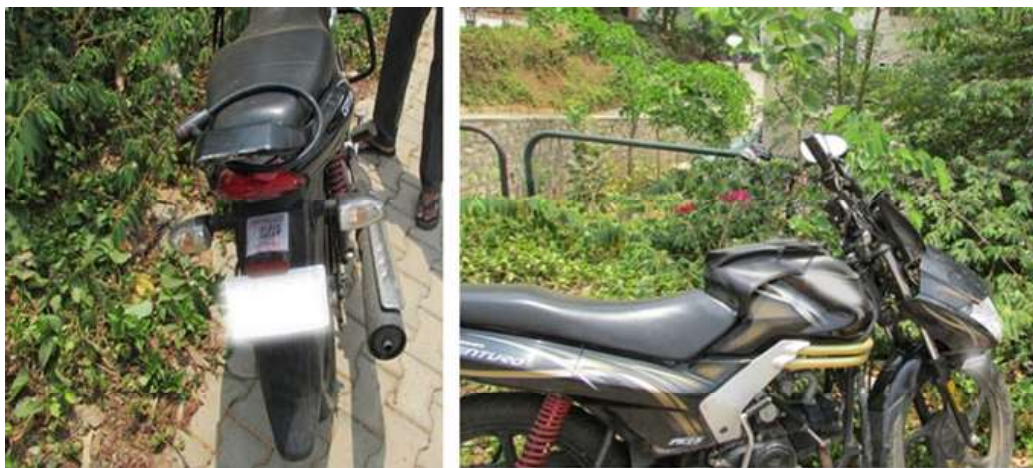
As part of the crash investigation, vehicle damages should be studied apart from the geometric study of crash spots. Hence, the authors inspected both vehicles after the crash, took photos, and collected service reports of vehicles. Figure 6 shows typical photos of the bike taken during the inspection. The bike's right side, back, and front side are intact; no damages are noticed. The bike had damages in the left side, i.e., Bummer folded, headlight cover, and left-side handle damage and petrol tank left-side damage. No car paint or impression is noticed on any part of the bike, and no service report was available from the bike owner or in the case document.

Fig. 6 Typical photos of bike after the accident, parked within campus

- The bike's left handle bar damages were noticed due to the pavement surface, which is also confirmed as pavement damage reported in Sect. 4 of the accident location study.

- Other damages, scratches, and dent in the bike may be caused by bike interaction with the pavement surface. No evidence was found to say car hit the bike as the right side and front part of bike is intact.

- Bike damages on the left side indicate that after colliding with the car the bike fell on the left side, which caused damage to the left side of the bike and not on the right side, which is evident from structural damage to the main road.

- We can also infer that when a car hits a bike in a stopped position, the right side of the bike should be damaged, but in this case, the right side of the bike is intact and no damages are seen from Fig. 6. We can infer that the bike was also in motion at the time of the collision which hit the car, lost balance, turned left side, and moved under the car. So the left side of bike got damaged after hitting car on the main road and caused structural damages to the pavement surface.

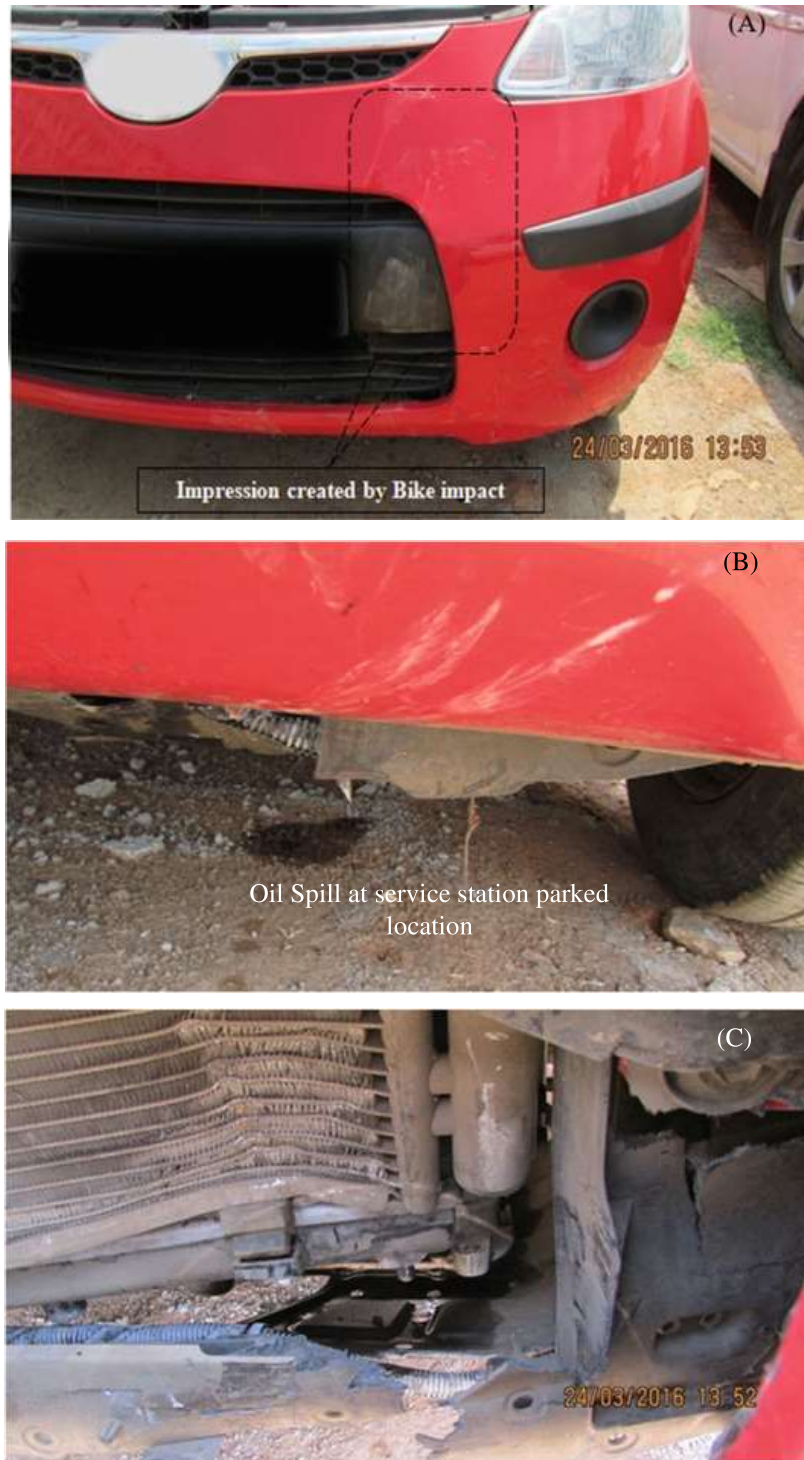
have taken several photos and also collected on spot service report with recommendation and service station inspection and estimate. Figure 7 shows typical photos taken during the inspection. Quick visual observation of the car gives the impression that car was not damaged much, except for few scratches and dents (Fig. 7a) in the front between the number plate and left side of a car headlight. We also noticed the bike tyre impression next to the number plate. It indicates that bike hit a car in a straight and opposite direction of car driving direction. Further interaction with car driver and owner, service person and study of on-spot service report, we deepen our inspection. Figure 7b shows oil spill at a service station parked location similar to the oil spill marking in Fig. 3b. After seeing an oil spill, inspection shows the damage of car bumper, radiator, A/C components, oil pumps, and associated spare parts in the left front of the car and the bottom up to the left middle of the car. The photo was taken by placing a camera after lifting of damaged bumper and shown in Figs. 7c. Now, it is clear that damage of a major portion of radiator and front units results in car's non-operation driving status, which is why it was suggested to tow vehicle by inspection report. A study of the estimation of the service station revealed that replacement of most of the above spare parts of car was estimated to be Rs. 51,393.

- Bike wheel mark impression on car bumper and associated scratches, dent in Fig. 7a shows that bike hit the car. Further, car bumper was broken and damages in the major front assemblies of the car such as radiator, A/C components, and oil pumps (Fig. 7b) were observed. This clearly shows that the bike might have hit the car with higher acceleration than car i.e., speed of the bike might be more than the speed of the car.

- Figure 7 shows clearly that the number plate and left headlight of car (Fig. 7a) is intact after the collision. In general, when the car hits another vehicle like bike, the front portion of car such as the front number plate and head light will get damaged. In the present case, since the number plate of the car is intact and the

Fig. 7 Photos of car after the crash taken at the service station. **a** Car front with number plate, scratches and bike wheel impression created. **b** Oil and coolant leakage at the parked location and **c** damaged car radiator and A/C unit not visible outside

damages are on the left side of the bike, it suggests that the bike hit the car toward its left, i.e., between car number plate and headlight, which is possible only if bike hit the car and not when car hit the bike. Further, the bike was attempting to enter the main road toward the left of the car, which should ideally be from the right side. Bike should be damaged if car hit the bike, but it was not so.

- Figure 7c shows damages of radiator assembly and other parts of the car. Bigger damage impression on the radiator might be created by the impact of bike front wheel as the handle impression will be small. This suggests that the bike hit a car while in motion with a speed force that is above the design strength of the car radiator front panel.

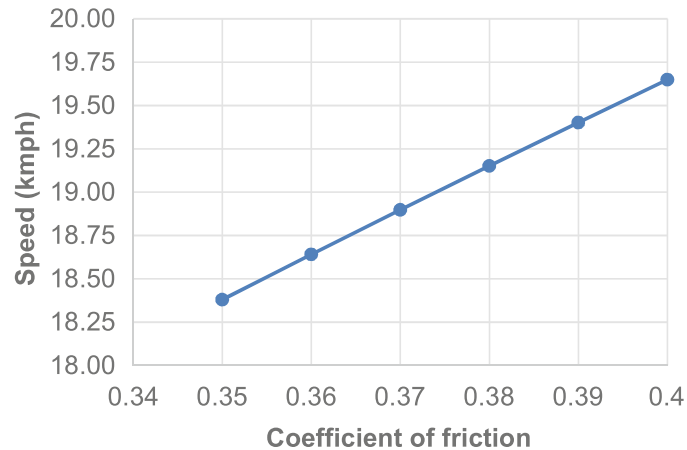
The speed of any vehicle (V in km/h) is a function of $d =$ braking distance (m), which is 3.8 m in the present case, and $\mu =$ coefficient of friction (unitless). The friction of the accident road is assessed as per the Indian Road Congress Guidelines and varies from 0.4 to 0.35 depending on speed from 30 to 80 km/h. Variation of the possible speed of car based on 3.8 m stopping distance by variation of coefficient of friction is shown in Fig. 8. It can be noted from the analysis that car speed might be

Fig. 8 Variation of car speed involved in the accident for the various coefficients of friction of the road

18 to 20 kmph. Even if maximum speed is taken, the estimated speed at the time of the accident is found to be 20 km/h, which is less than the speed limit of 30 km/h on the roads in campus and Bangalore city speed limit of 60 km/h. So, there is less chance that car might have caused accident.
