Reconnaissance report on geotechnical effects and structural damage caused by the 3 January 2017 Tripura earthquake, India

P. Anbazhagan¹ · Kunjari Mog¹ · K. S. Nanjunda Rao¹ · N. Siddharth Prabhu¹ · Ayush Agarwal¹ · G. R. Reddy² · Sima Ghosh³ · Malay Kr. Deb⁴ · Saurabh Baruah⁵ · Sarat Kr. Das⁶

Received: 16 August 2018 / Accepted: 30 July 2019 / Published online: 8 August 2019
© Springer Nature B.V. 2019

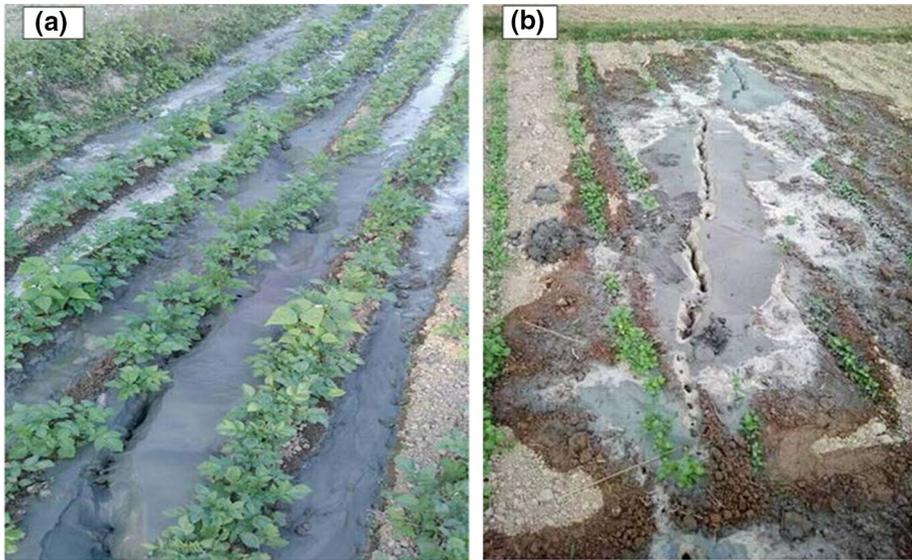
Local people working in the farmland had witnessed the surface sand boiling phenomenon very closely, which occurred immediately after the earthquake shaking in the liquefied site. The sand gushing with water had continued for about 15–20 min after the earthquake. Apart from these locations, liquefaction had also been observed in an open excavation (i.e., elliptical sand boils) and on the river bed. Most of the liquefaction signatures were noticed on river deposit or close to the river. Further, there was no liquefaction observed in the capital city of Agartala and surrounding area, which was far away from the epicenter location. The authors could not find any previously reported liquefaction induced by moderate earthquake magnitude in Tripura, and this is probably the first of such incident reported.

Fig. 6 a, b Liquefaction manifestations at surfaces as sand boils, immediately after the earthquake in an agricultural farm at Kanchanbari, Kumarghat, Tripura (photograph taken on 3 January 2017 collected from the local people)

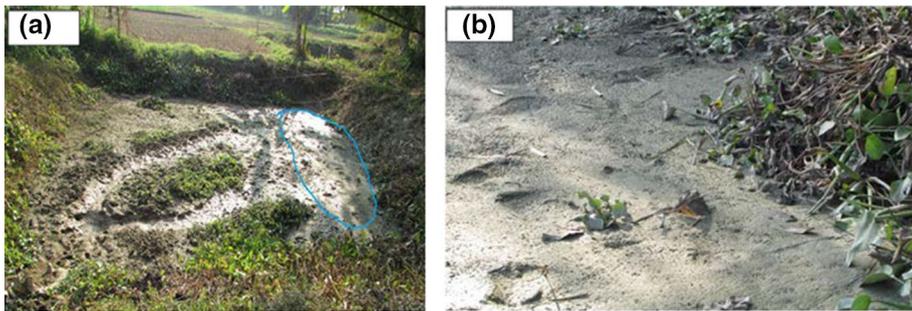
Fig. 7 a Observed liquefaction in one of the open excavations next to the agricultural farm land. The close-up view of the circled portion has been shown in **(b)**

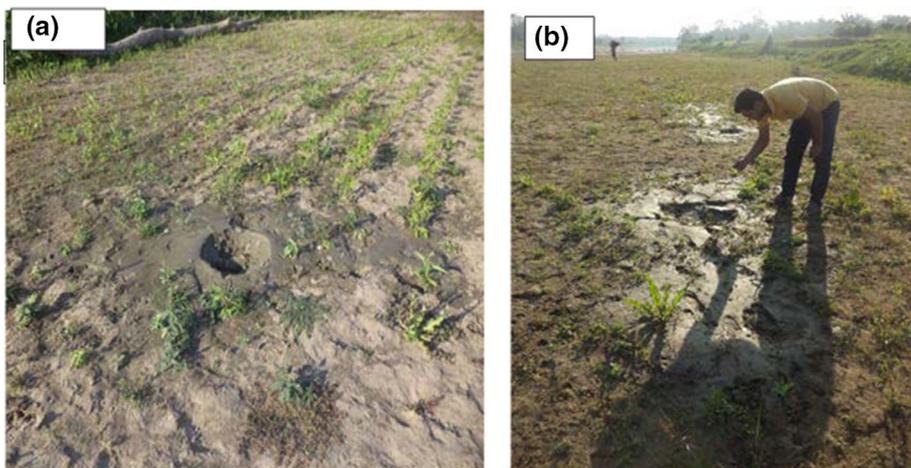
Fig. 8 a, b Elliptical shape sand deposits due to sand boils during liquefaction at the Manu river bank (photography by Rajesh Debnath)

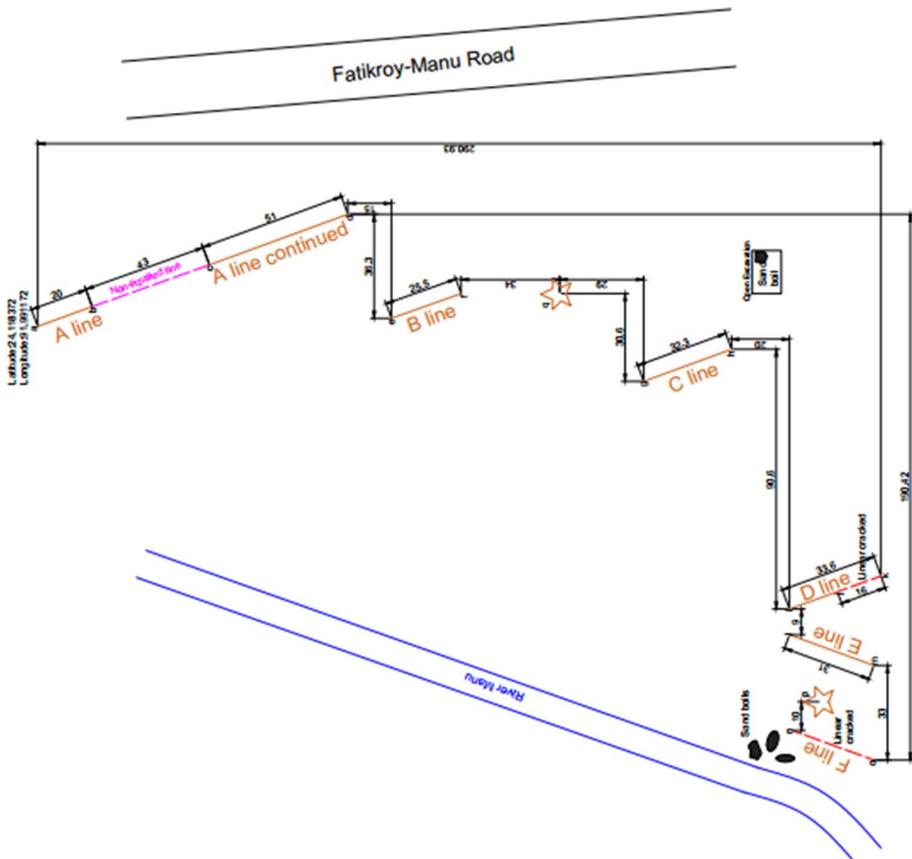
IISc team measured surface feature of liquefaction from the liquefied site (see Figs. 5 and 6), and it is shown in Fig. 9. Mapping of the ground feature of liquefaction as shown in Fig. 9 represents that, an array of linear sand boils was observed as depicted in the schematic diagram in Fig. 9. Lines A, B, C, D, E are the linear sand boils, and line F is the linear crack developed due to the earthquake. The thicknesses of sand deposits due to sand boil were measured to be about 120–150 mm above the existing soil. This indicates that duration of shaking was considerably high at the liquefied site to eject a significant amount of sand with water. On the line A, shown in Fig. 9, first 20 m (ab) had been liquefied following that the next 43 m (bc) is un-liquefied, but again sand boiling had started from c point and extended up to 51 m in length until d. The length of the lines B, C, D, E and F was 25.5, 32.3, 33.6, 31 and 17 m, respectively. One point can be noted here that lines A, B, C, D were nearly parallel to each other except the lines E and F. The line F is a linear crack of width about 100 mm. From the schematic diagram, it can be clearly observed that liquefaction occurred in a curvilinear trend that extended up to the bank of the River Manu. Three to four numbers of elliptical sand boils were seen on the river bank, which was just next to the line F, and one sand boil was observed in an open excavation shown just above the line C. The distance between the liquefaction starting point (from point a) and the river was about 125.5 m.

Fig. 9 Schematic representation of the liquefied area at Kanchanbari, Kumarghat, Tripura, India (24.118°N and longitude 91.991°E)

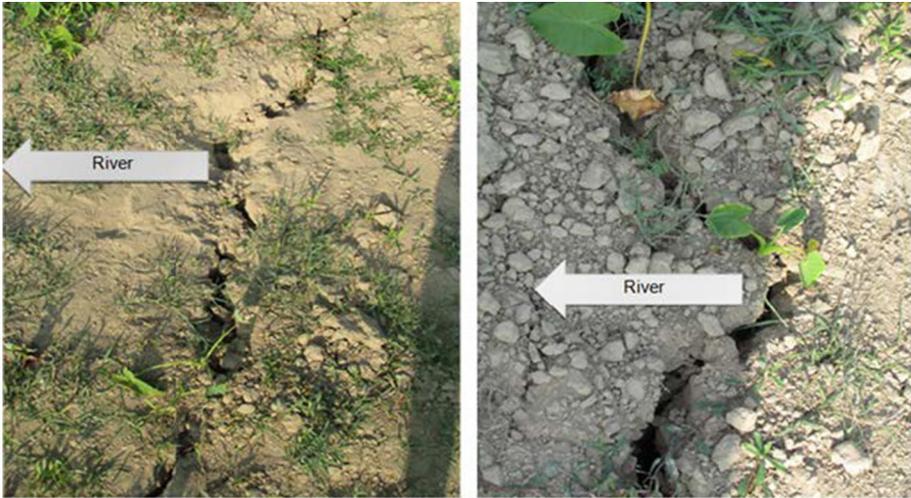
Fig. 10 Lateral movement of the ground toward the river Manu is observed at Kanchanbari, Tripura

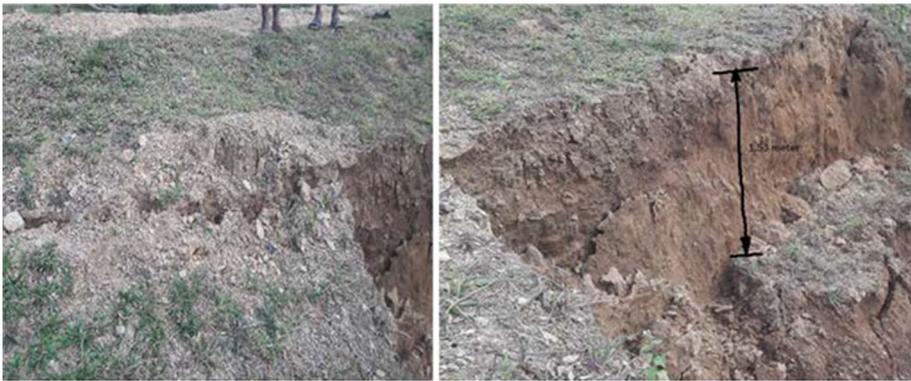
Fig. 11 Surficial slope failure at one of the ponds in Kumarghat, Tripura

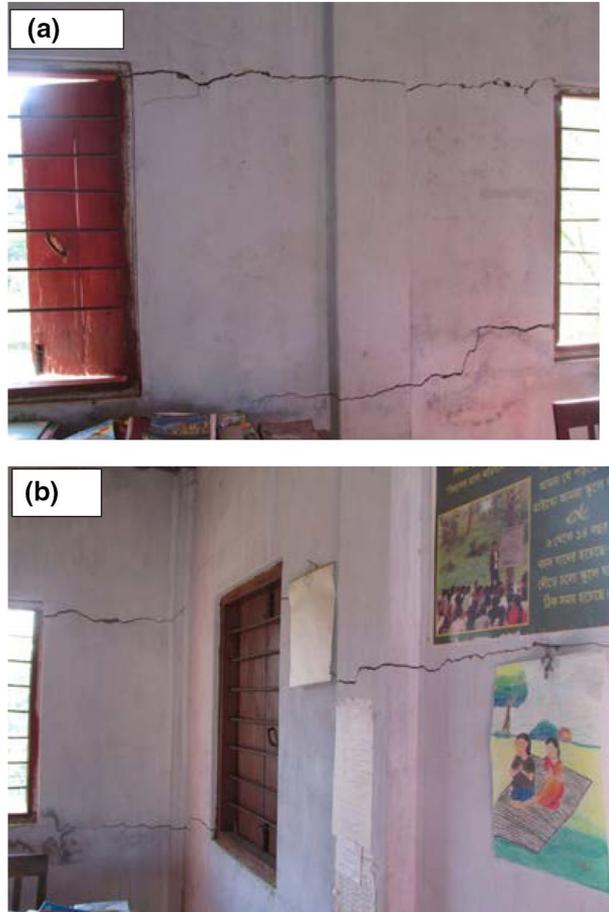
Figure 12a, b shows damage caused to a masonry building with light GI (galvanized iron) sheet roofing. The building serves as a school. Horizontal cracks are developed in the masonry long wall in between the window openings at the sill and lintel levels. The cracks have extended up to the corner, and similar cracks have been found in the orthogonal wall as well. The cracking can be attributed to out-of-plane flexure, indicating poor flexure bond strength of masonry. The building is in seismic zone V as per Bureau of Indian Standard (BIS 1893 2002). It is a non-engineered building lacking in basic earthquake-resisting features like lintel band.

Fig. 12 a, b Damage caused to a masonry building with light GI (galvanized iron) sheet roofing which lacks lintel band

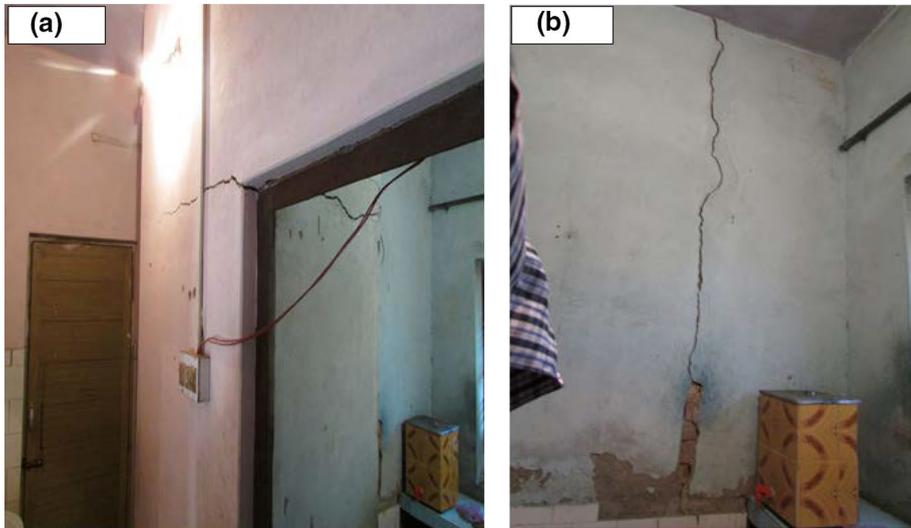
The damages suffered by a two-storied load-bearing masonry building are shown in Fig. 13a, b. The damages were in two dwelling units of the building located on the ground floor. The building served as housing for the police personnel. In one of the dwelling units in the orthogonal wall (Fig. 13a), horizontal crack at the lintel level was observed. There is a vertical crack observed in one of the walls (Fig. 13b) adjacent to the corner.

Fig. 13 a, b Damages suffered by a two-storied load-bearing masonry building

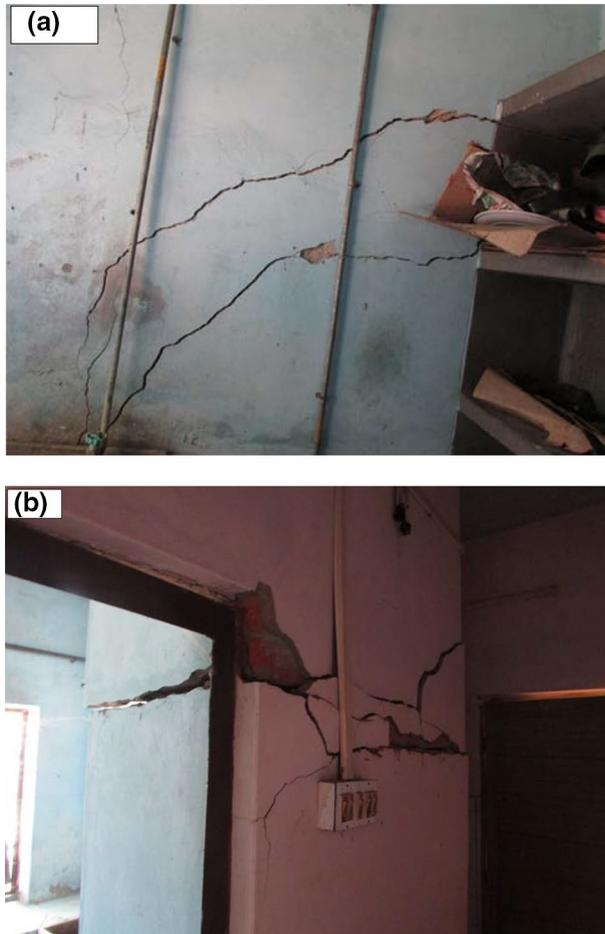
The damages caused to the other dwelling unit in the same police station are shown in Fig. 14a, b. The cracks initiated from the floor level (Fig. 14a) and propagated in an inclined direction and reached the lintel level of the adjacent orthogonal wall (Fig. 14b). The cracking can be attributed to combined effect of shear and flexure. Even though the building is engineered, it has suffered damage possibly due to poor construction practices.

Fig. 14 a, b Damages caused to the dwelling unit in the police station due to poor construction practices

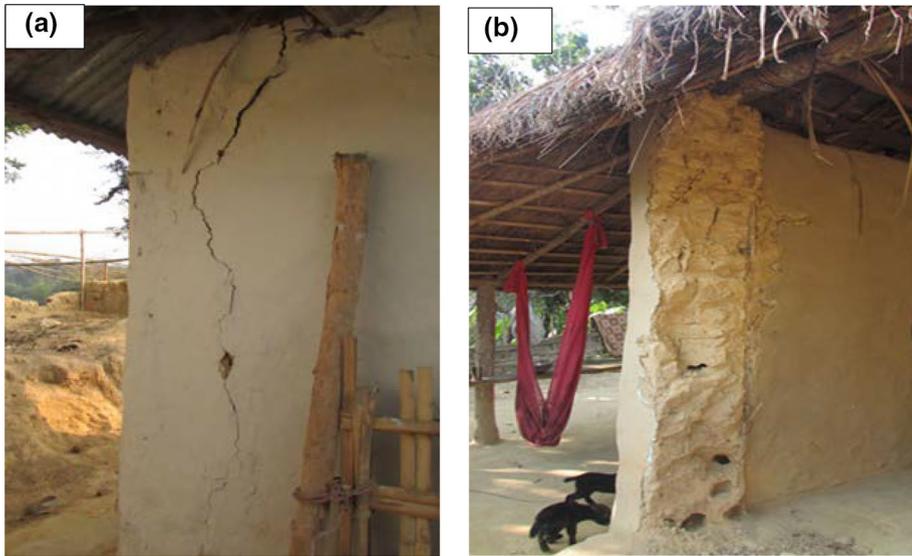
Fig. 15 a, b Damages of the two mud houses due to the formation of vertical crack at the corner and out-of-plane collapse failure

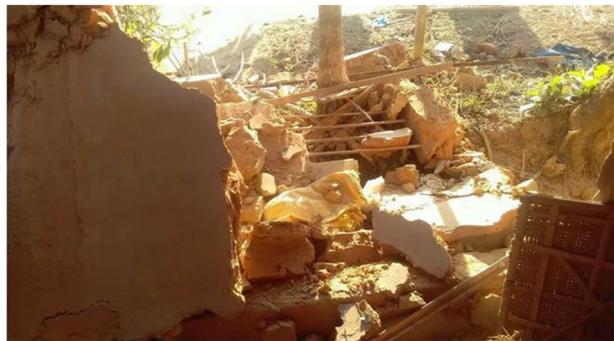
Fig. 16 Out-of-plane failure at one of the mud houses in Tripura

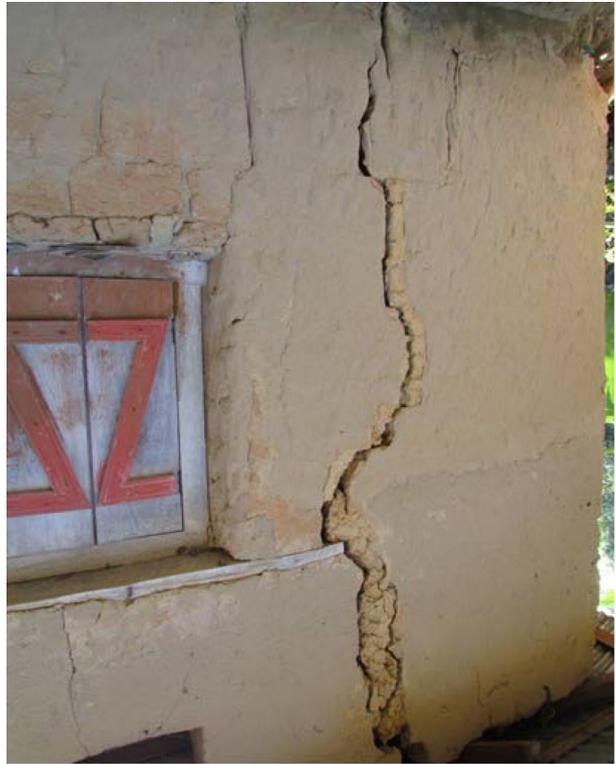
Fig. 17 Lack of lintel band at mud house

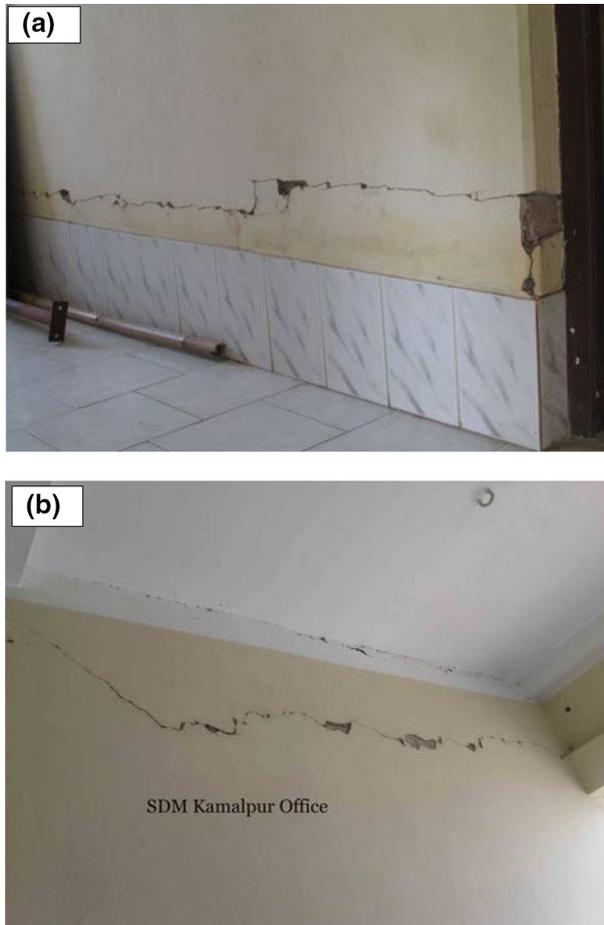
The failure patterns observed in a two-storied RC frame with masonry infill building are shown in Fig. 18a, b. It can be observed that cracks are essentially in masonry infill in the horizontal direction indicating sliding shear failure. The buildings served as Kamalpur Sub-Divisional Magistrate office in Dhalai District, Tripura, India.

Fig. 18 a, b Sliding shear failure at two-storied reinforced concrete frame buildings

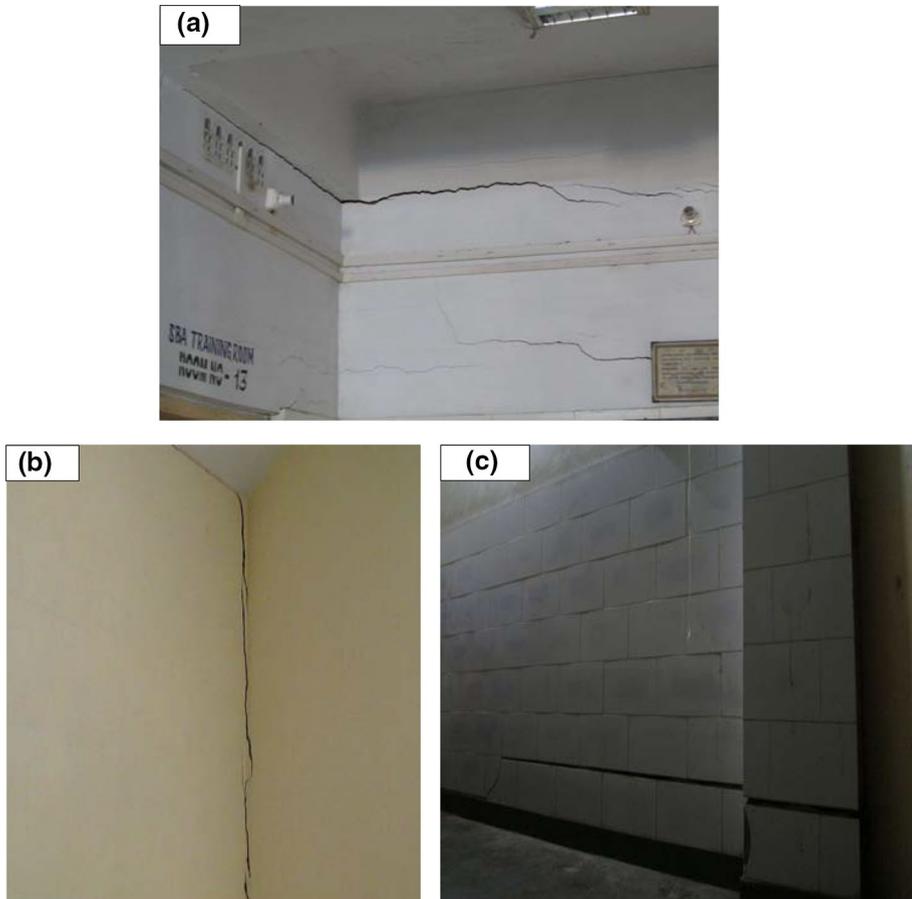
The damages observed in another two-storied RC frame with masonry infill building are shown in Fig. 19a–c. The building is served as Kamalpur BM hospital which has suffered structural damage in several locations in this earthquake. Two of the rooms, namely the ultrasonography and X-ray, suffered severe damage. The medicine storage racks were not properly anchored; as a result, medicine bottles toppled and fell to the ground. The cracking is essentially in the masonry infill in the horizontal direction. The cracks were initiated in the masonry wall just above the lintel level and have propagated to the junction of roof slab with the wall and extended to the corners. At the corner, the crack (Fig. 19b) was in the vertical direction separating the two masonry walls. Figure 19c shows horizontal crack just above the plinth level in the masonry wall. The cracks were observed on both faces of the wall at the same level. The damages can be attributed to combined flexure and shear.

Fig. 19 a–c Damages observed in two-storied RC frame hospital building with masonry infill

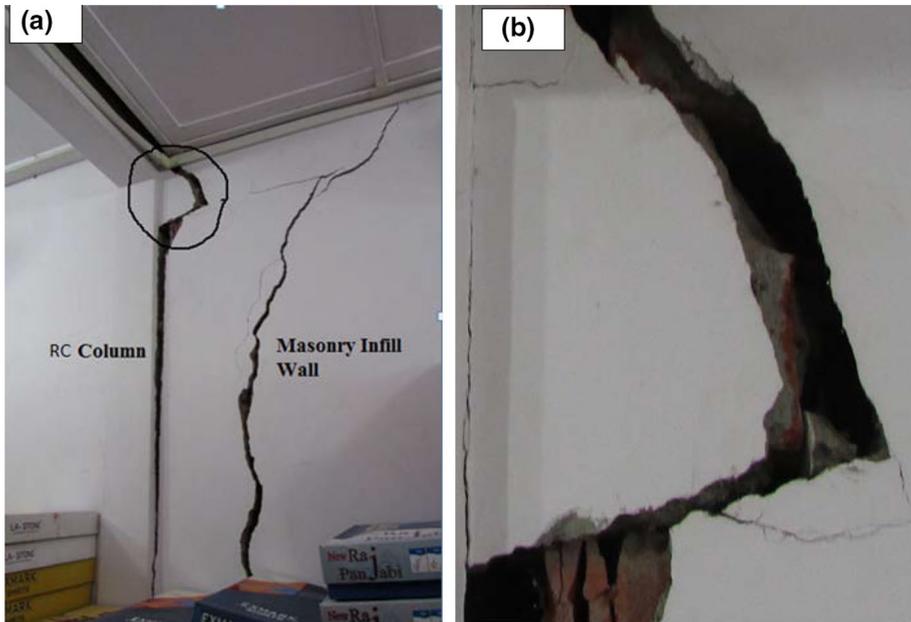
Figure 20a shows damages in the form of vertical cracks in the masonry infill's adjacent to RC column in shop building located at Kumarghat, Tripura. The enlarged view of the circle portion is shown in Fig. 20b.

Fig. 20 a Formation of vertical cracks in the masonry infill reinforced concrete wall and b cracks in RC column–masonry wall joints

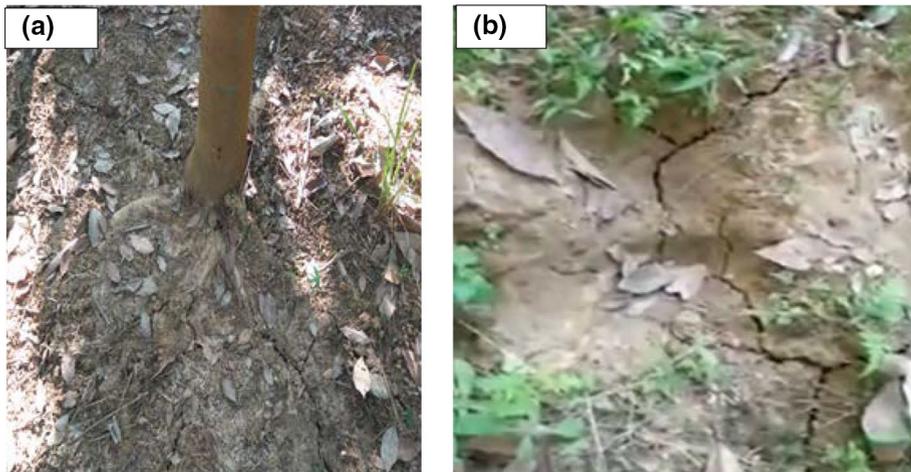
Fig. 21 a, b Surface cracks at the epicentral area located at the top hill of Longtharai, Dhalai, Tripura
