# CURRENT SCIENCE

## Field investigation of the 30 September 1993 earthquake in Maharashtra

R. N. Iyengar\*, C. S. Manohar and O. R. Jaiswal

**An engineering field study of the 30 September Marathwada earthquake is reported. The study covered Osmanabad, Latur, Sholapur, Bijapur, Gulbarga and Bidar districts. The level of ground acceleration was estimated based on tilting of free standing objects. The study shows that the epicentral intensity has been VIII on the UNESCO scale. The horizontal ground acceleration near the epicentre has been estimated to be about 0.2 g.**

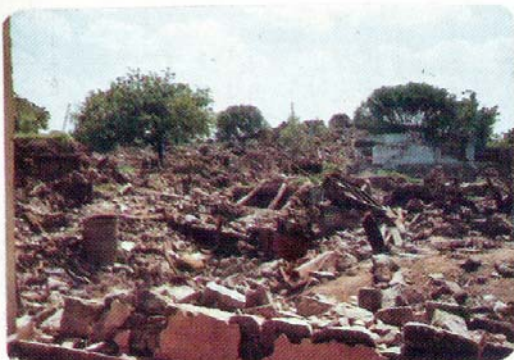
Figure 4. Khilari; Type A structures, grade 5 damage.

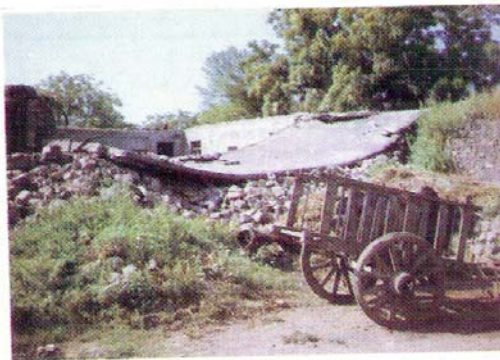
Figure 7. Kavatha; Type B structure, grade 4 damage.

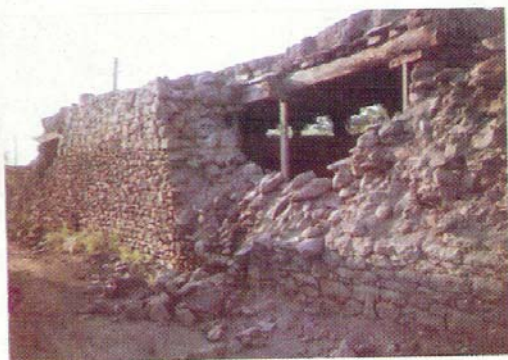
Figure 5. Khilari; Type A structure, grade 4 damage.

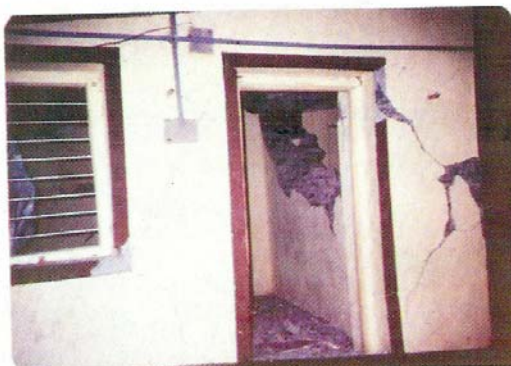
Figure 8. Khilari; Type C structure, grade 3 damage.

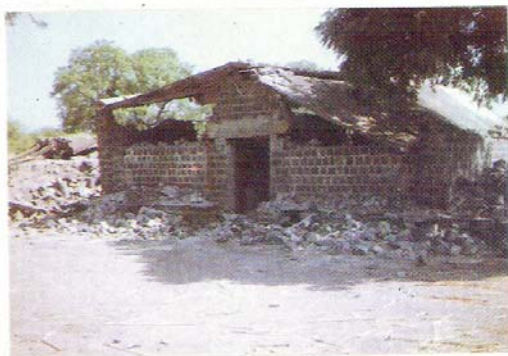
Figure 6. Rajegaon; Type B structure, grade 4 damage.

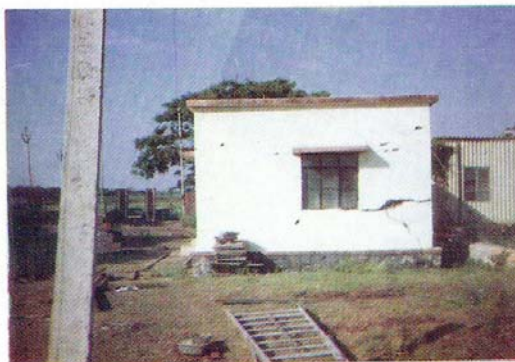
Figure 9. Sastur; Type C structure, grade 3 damage.

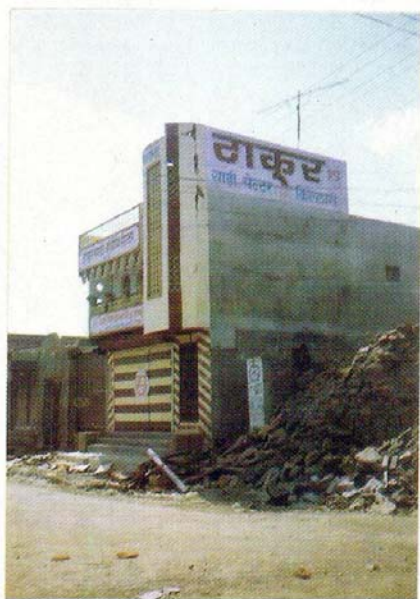
Figure 10. Khilari; Type C structure, grade 2 damage.

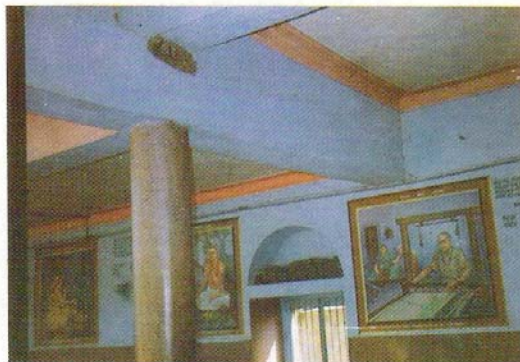
Figure 12. Basavakalyan; Type C structure, grade 1 damage.

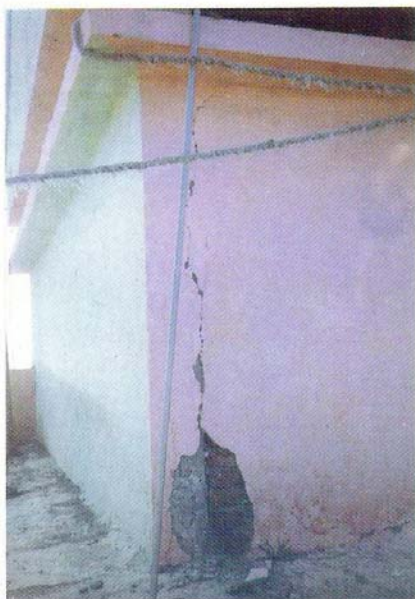
Figure 11. Umarga; Type C structure, grade 1 damage.

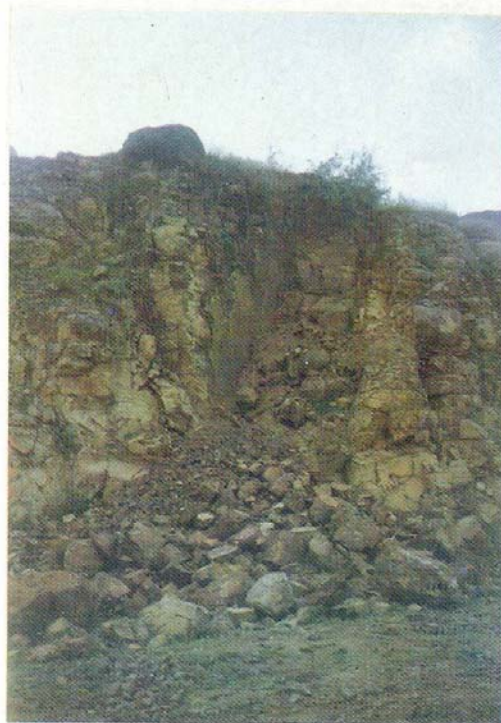
Figure 13. Landslide near Basavakalyan.

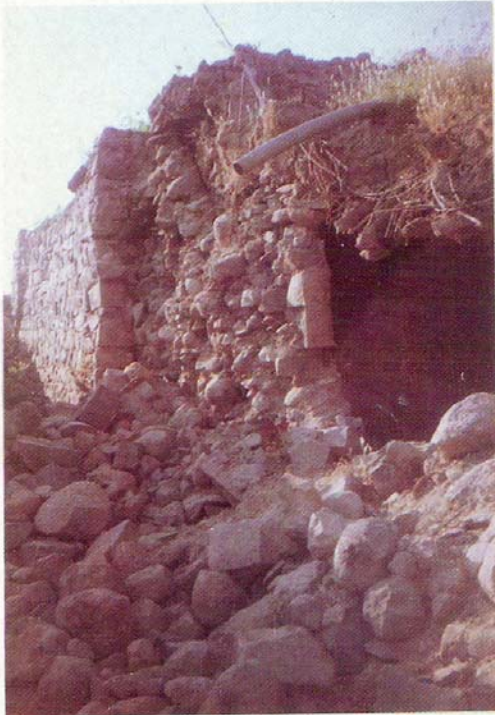
Figure 14. Bhosga-K; Type A structure, grade 4 damage.

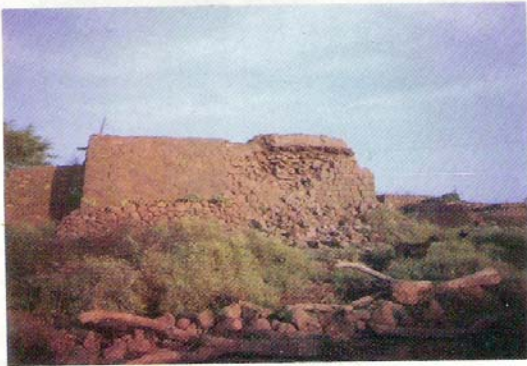
Figure 15. Bhosga-K; Type A structure, grade 3 damage.

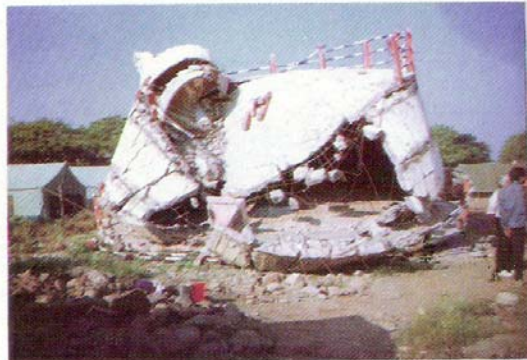
We inspected several engineered structures such as water tanks, earthen dams, hydraulic works, bridges, industrial structures and electric substations in the affected area. Figures 16–19 show some of the conspicuous scenes of damage observed. Among these, the catastrophic failure of the overhead water tank at the epicentral village of Kavatha is the most striking (Figure 16). This structure had a spiral staircase adjoining the circular tank portion which made the structure asymmetric in plan. Further, the tank was reportedly partially filled at the time of the earthquake. It is of interest to note that a water

Figure 16. Circular water tank at Kavatha.

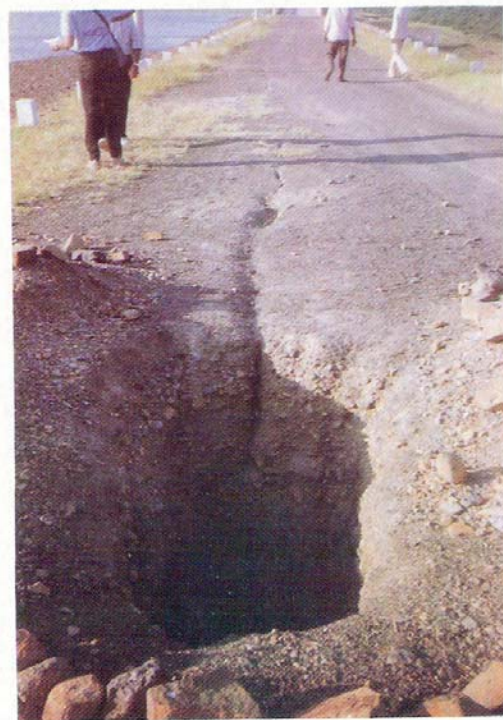
Figure 17. Crack on the top of the Makni dam (pit was dug for inspection).

tank of similar design has survived the earthquake in the town of Umerga 20 km away. Also, rectangular overhead water tanks in the epicentral villages of Khilari and Sastur are still safe. The earthen dam at Makni, about 15 km away from Khilari, developed a 15 m long, 1.2 m deep and 10 to 15 cm wide longitudinal crack at the top (Figure 17). This dam is about 15 m tall, 1.5 km long and has a central concrete masonry control structure of about 400 m long flanked by earth sections. In the top portion of the dam, junctions between the masonry and earth parts showed signs of severe distress. The earthen dam at the Upper Mullamari project near Hallikhed-K, in Bidar district, about 70 km away from the epicentre has remained unaffected. On the other hand, a 200-year-old stone masonry earth-retaining structure collapsed in the village of Kohinoor Pahad, Bidar district, at an epicentral distance of 50 km (Figure 18).

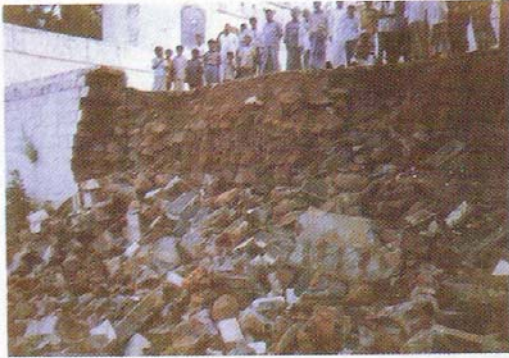
Figure 18. Retaining wall failure at Kohinoor Pahad near Basavakalyan, Bidar district.

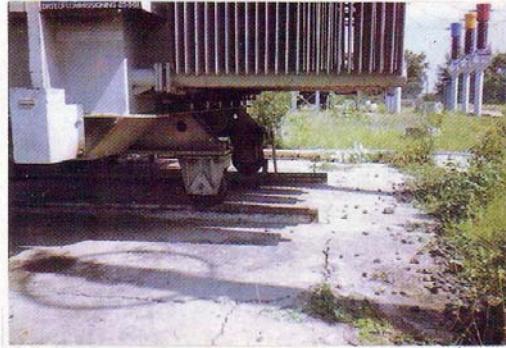
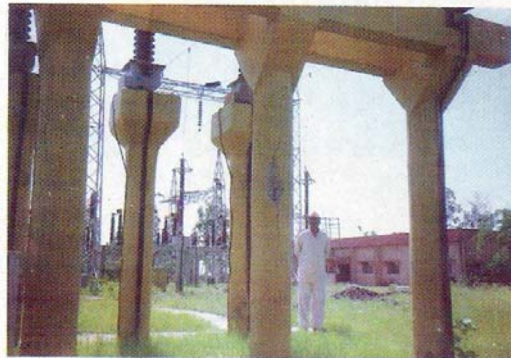
Figure 21. MSEB substation at Umerga.

By and large, there was no significant damage to industrial plants in the epicentral region. However, minor damage to brick chimneys and machine foundation bolts was observed in the khandasari factories near Basavakalyan and Humnabad. Signs of land settlement leading to structural damage were observed in the 132 kV electric substation in Umerga. Here, the ground floor within a RC frame structure had subsided by about 2 cm over an area of 5 square meters. In the same place, the foundation slab of a transformer had also cracked due to ground subsidence (Figure 21). Damage to RC columns supporting the insulators can be seen in Figure 22. In the 33 kV electric substation in the epicentral village of Sastur, RC structures suffered considerable damage. In addition, the contact plates in the isolators were broken and also bolts at the joints reportedly came out. In the epicentral region, the electric poles, transmission and communication towers were largely unaffected. At a few places, however, I-section steel poles were seen

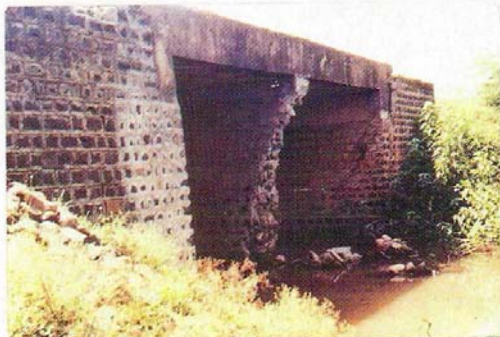
Figure 19. Damaged pier of Rudrawadi culvert near Aland, Gulbarga district.

Cracks were observed at the abutments of a few bridges on the national highway between Humnabad and Umerga. The central pier of the Rudrawadi culvert near Aland, about 55 km away from Khilari was considerably damaged (Figure 19). Several culverts and parapets of small bridges in the epicentral region have also suffered damage. Near Khilari, cement concrete pipes of small culverts were damaged. The piers of a stone masonry hydraulic control structure, which was under construction near Rajegaon, have extensively cracked at about mid-height (Figure 20). The RC pads on the top of some of the piers have also cracked exposing the reinforcement at a few places. About 50 km away from the epicentre, RC aqueducts of the Upper Mullamari irrigation works near Hallikhed-K have cracked leaving open the steel at a few places. Some minor distress was also observed at aqueduct canal junctions.

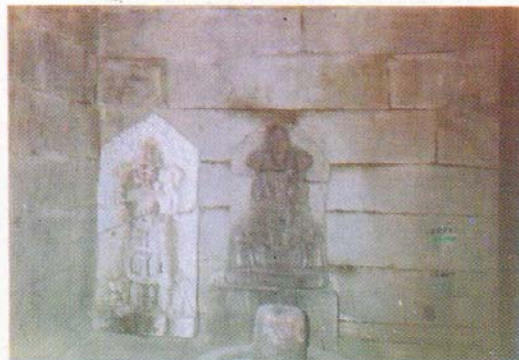
Figure 23. Broken idols in Kavatha temple.

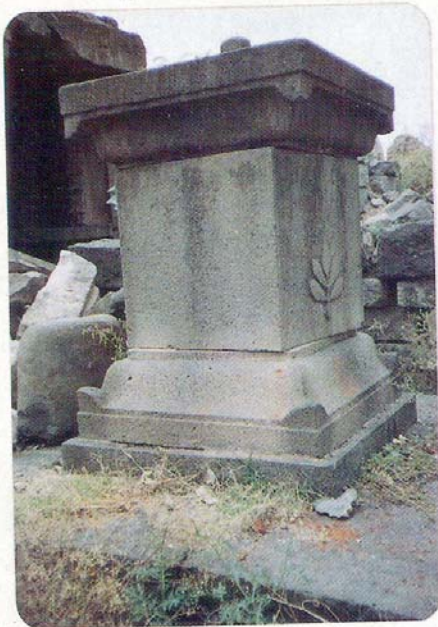
Figure 24. Clockwise rotation of stone block in Kavatha temple.

We also made a few observations on rotations of rigid blocks. Figure 24 shows a 3° to 4° clockwise yaw motion of a stone block in the Chalukyan temple complex in Kavatha village. About 200 m away in the same village, another stone block of a later period has yawed in the same fashion. Similar clockwise rotation was also observed in a stone block in front of the Vitoba temple in the river bed near Rajegaon. From the sense of these observed rotations, it may be surmised that both Kavatha and Rajegaon are located on the same side of the rupture plane. If more objects which have rotated in plan can be reliably located, it may be possible to fix up approximately the location and direction of the rupture.

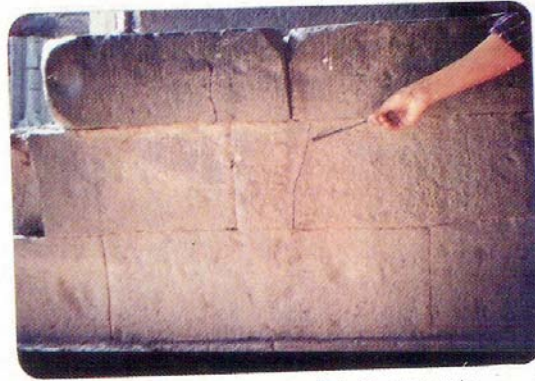
Figure 25. Cracked stone wall in Kavatha temple.

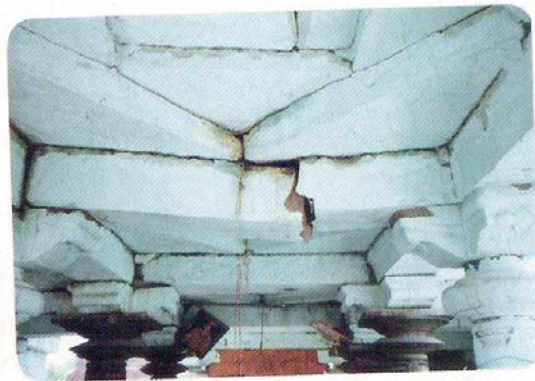
Figure 26. Broken stone beam, Ambabhavani temple, Khilari.

The monumental structures in and around Khilari are mostly temples built during the Chalukyan period. The exact dates of these temples, called locally Hemadpanthi temples, are not readily available. We have been able to gather from historians that these might have been built during 1000–1300 AD. Study of these temples was scientifically, and otherwise, quite revealing. The study of free standing objects such as lamps, idols and marking stones was useful in gaining some idea about the level of ground acceleration. The Chalukyan temple complex at Kavatha (Figure 23) with broken idols was also the site of rotation of a massive well dressed stone block (Figure 24). In the same temple complex, dressed rectangular stone blocks in three parallel walls got sliced between the joints (Figure 25). There is a huge stone inscription outside the temple wall in Kannada script. We have not been able to decipher whether any date is mentioned in this. However, based on the photographs, a few historians suggested that the temple could belong to 11–12 century AD. From local inquiries it was learnt that at least the southernmost shrine was functional and regularly visited by worshippers. The present earthquake left this structure badly damaged. The brick-in-mortar spire had collapsed along with the metal cap. The integrity of the outer walls is drastically lost, with the corners looking out of plumb. A few stone lintels are broken giving a feeling of precariousness to parts of the structure. There is a temple of similar style in Khilari town which perhaps belongs to the same period. This is called the Ambabhavani temple, where again the lintels are broken (Figure 26). The remarkably beautiful stone columns are fractured at the bottom due

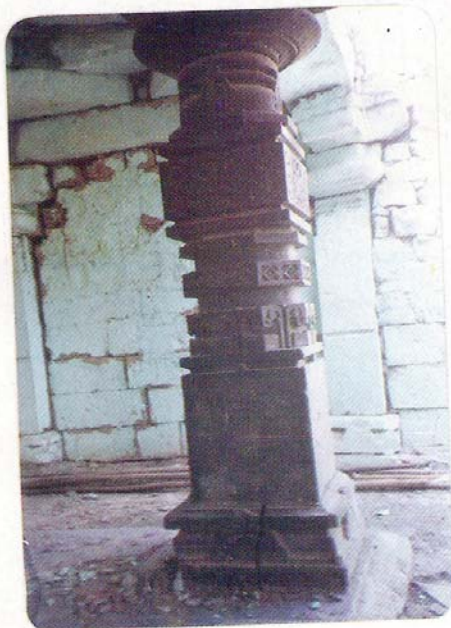
Figure 27. Fractured column, Ambabhavani temple, Khilari.

to the earthquake (Figure 27). Thus, even though it is not possible to say when a past earthquake of magnitude greater than 6 *M* occurred in this area, we may make an educated guess. Had an earthquake of the same or higher intensity visited this place in the past, it probably dates back to a period preceding the construction of these temples, which remained intact till the present earthquake occurred. If this argument is accepted, it follows that in the last 600–700 years no strong earthquake has visited, at least, the present epicentral tract of the Marathwada region. This, to some extent, explains the prevalence of local construction practices which do not take cognisance of possible seismic activity. However, this may not mean that there have been no strong earthquakes in historical times. For example, the village of Thair, which is 50 km NW of Khilari, is historically a most interesting place. Here, the damage from the present earthquake is not at all severe. Archaeological excavations have revealed that this place, formerly called Tagarpura, was a flourishing town some 2000 years ago, but then got ruined. Local villagers talk of earthquakes as being the cause of ruination. While this at present is merely speculation, palaeoseismic investigations are called for to ascertain this possibility.

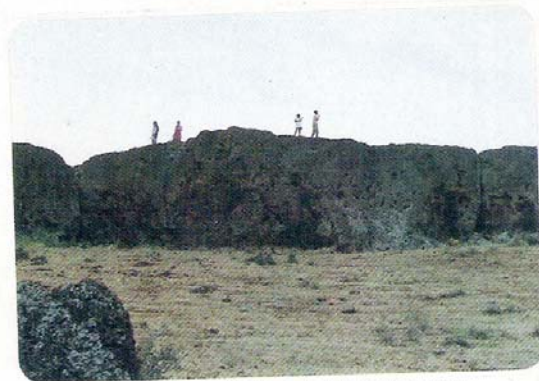
Figure 28. Old fault on Lamjan-Nilanga road.

The effect of the earthquake on the natural relief could not be studied in detail. At Khilari and Rajegaon, there were reports of ground cracks, which got closed due to the heavy rains which followed the earthquake. Thus, we could not verify these reports. However, away from the epicentre, we observed two instances of ground cracking. The first was in Gulbarga district in village Alanga in Aland taluk. A nearly 30 m long, 2 cm wide crack could be seen on the ground ending up at a nearby borewell. In the village of Thair, the floor in a hut showed a crack running nearly in the NW-SE direction. The crack was nearly 5 cm wide and was visible for about 30 m in the open field also. An interesting geological feature near the epicentral region is an old fault with a vertical uplift of the ground (Figure 28). This can be seen in the fields to the right of the road connecting Lamjan and Nilanga. The vertical face of the exposed part is considerably weathered. On both sides of this East-West running fracture, the ground

is nearly level and is cultivated. Local people call the place Kengal, which means red stone. The soil nearby looks brick red, with a large number of pebbles strewn out of the vertical face of the uplifted ground. No fresh movement of the fault is apparently visible to the eye. Geological study of this feature is essential to understand the tectonics of the region.
