## Forensic investigation of earthquake induced failures during Sikkim 2011 earthquake, India

Anbazhagan P<sup>i)</sup> and Murali Krishna A<sup>ii)</sup>

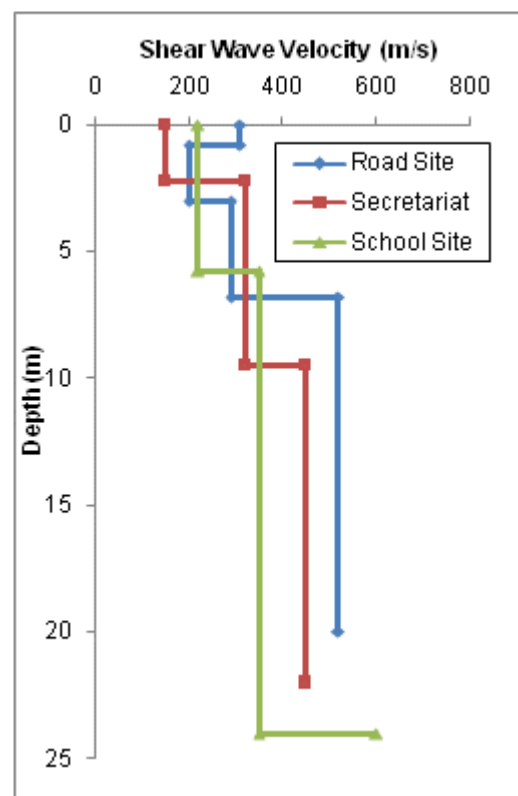
Fig. 2 Shear wave velocity with depth obtained from MASW survey

SWV velocity profile close to secretariat building is shown in Figure 2. Very loose material having shear wave velocity less than 180 m/s found up to 3 m and followed by medium dense soil with SWV of 320 m/s up to 10 m and followed by hard/rock layer. GPR radargram using a low frequency antenna of 25 MHz is shown in Fig 10.

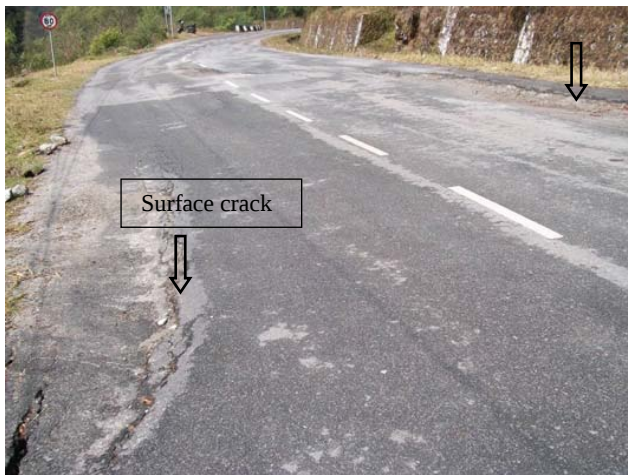
This particular site was located at the Western bay pass, Bulbulay Road, Gangtok (1 km away from Tashi view point towards Ganeshtok). Circular slide inducing cracks, settlement on the road and lateral movement of slope were observed. Incipient landslide condition. Field Photo is shown in Figure 3 and MASW and GPR survey lines are shown in Figure 4. MASW study shows that about 0.5 to 1.0 dense layer with SWV of

about 350 m/s found due to pavement section and followed by loose material with SWV of less than 200 m/s and the SWV increase with depth. Soft material below the pavement layer and above rock/hard layer might experienced reduction in strength due to saturation and cyclic loading which might cause partial slope failure in this site. Typical radargram from GPR is shown in Figure 5. GPR radargram shows layers of dense and loose layers similar to MASW data. GPR also shows the movement of layers due to slip formation. Presence of heterogeneous layers below pavement might caused cyclic mobility and resulted slip movement.

Fig. 3 Road damage due to landslide at Bulbulay road, Gangtok

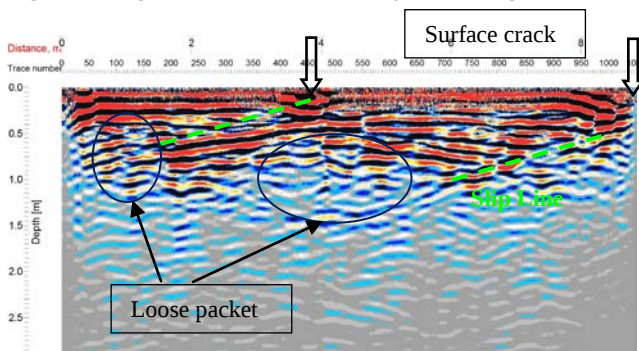
Fig 5. A typical GPR profile of the cross section of the road using a 500MHz GPR antenna

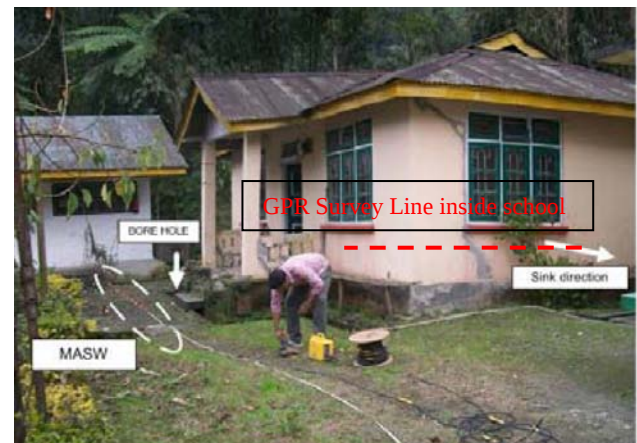
earthquake. Settlement of the building and tilting because of the uneven settlement has been observed as shown in Fig. 6 The single storied building under study was constructed on a filled up soil. According to local people there was a lake before and the land was reclaimed for constructing the house. The adjacent school building remains intact with some minor cracks but the building under study has suffered extensive damage. MASW and GPR tests were conducted. Soil samples were also collected at the location. It can be observed from MASW SWV (Fig 2) that presence of loose soil on the surface up to a depth of 5 m, where the foundation of the building was housed. Borehole samples also reveal the soil found in that poorly graded sand (SP) with more of sand fraction material. Figure 7 shows GPR radargram from inside School. Non uniform subsurface layers observed, which might have resulted due to filling of existing lake. The findings of this study confirm the presence of loose soil below the floor and foundation, which have caused loss of shear strength due amplified dynamic load. It is suspected the settlement of the filled up soil due initial liquefaction and local site effect.

Fig. 6 Distressed School Building at Upper Dzongu

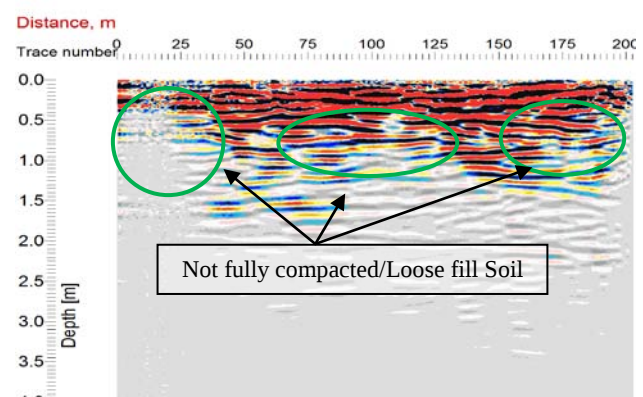
Fig 7. A typical GPR profile radargram below distressed school buildings using a 500MHz GPR antenna

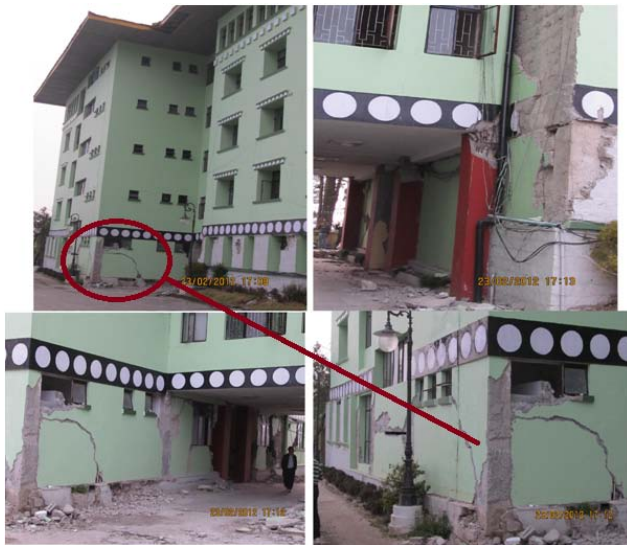
Old Secretariat building, Gangtok, Sikkim is located at 27.32463°N , 88.61430° E, 1701 m elevation. Extensive structural damage of the 5 storied framed structure with masonry infill was observed. The earthquake resulted in a severe damage in the [part of the Secretariat building resulting in cracking of the structural members. It can be highlighted that one part i.e back side of the building damaged more when compared front side building (Fig 8). This building is structurally sound and designed according to seismic code. A GPR survey carried out from front side back side to get subsurface soil layer and rock depth. MASW survey carried out close to back side as shown in Fig 9.

Fig. 8 Photos of damaged secretariat building

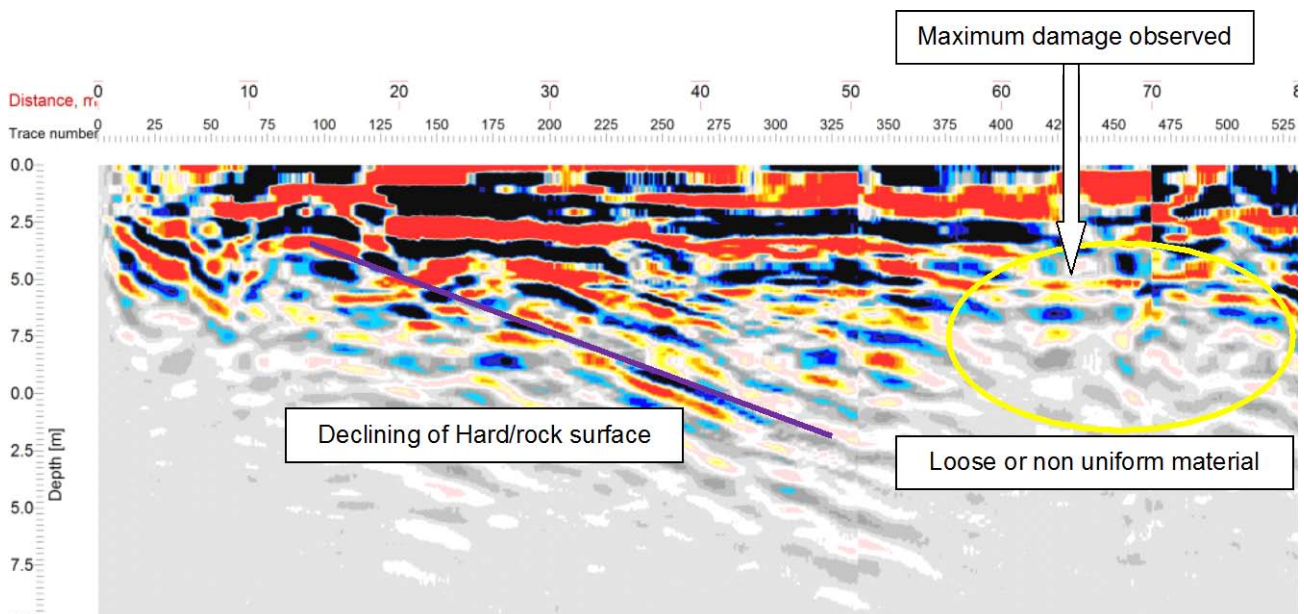
It can be observed from Fig.10 that the front side of secretariat building having a hard layer (more reflection) close to surface and depth of the rock / hard layer keep increasing toward backside.

Fig. 10 GPR radargram shown variation of soil thickness at secretariat building

Depth of rock/hard layer is about 7 m to 10 m close to damage location, which is matched well with MASW SWV observations. The presence of loose soil also observed at the back side of the building. Overall site subsurface profiling shows that depth of soil at the front side (no damage) is less or nil and more at the back side of the building. Non uniform thickness might cause non uniform site effects. Ground motion at front side is less and there may not be any site amplification due to absence of soil. Site effects and amplification might have occurred due to loose soil filled close to back side of the building resulted more ground motion when compared to the front side of building caused extensive damage at only back side. As the building was constructed by similar design and construction and non uniform amplification cause damages at one side of the building. More detailed numerical analysis is required to prove our interpretation. Even though there significant advancement made in earthquake Geotechnical engineering, still we need a more forensic study to understand these kind of peculiar seismic failures.
