Intensity based building damage level prediction model from past Earthquakes for risk assessment

Abstract

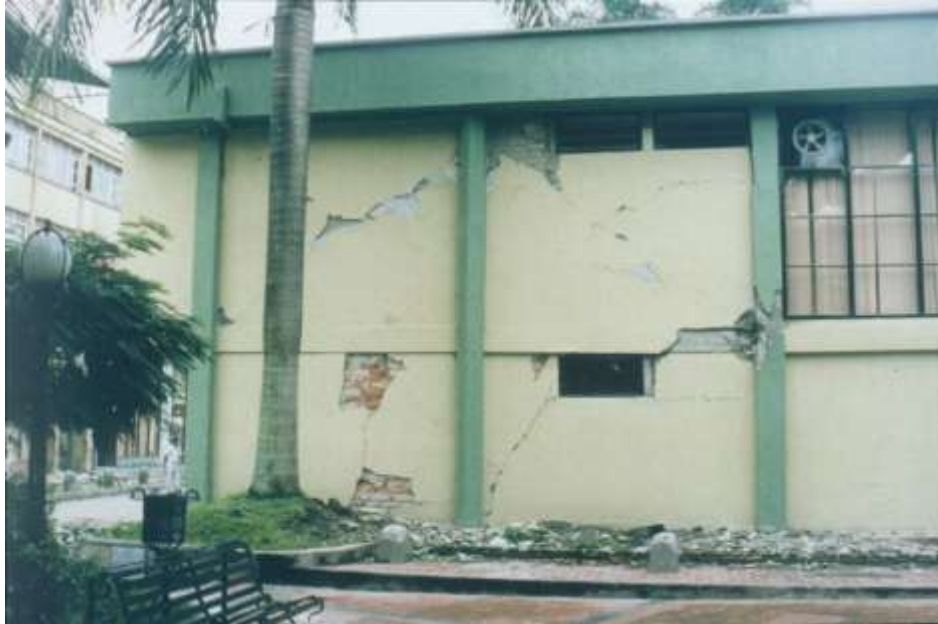
Fig. 2: Municipal building in Armenia, Colombia
(<http://www.ngdc.noaa.gov/hazardimages/picture/show/824>)

Damage description: The structure (Fig. 2) is a two storeyed storied municipal building in Armenia located at a distance of 96.5 km from the epicenter of the 1999 Armenia $6.2 M_w$ Earthquake. The reported local intensity was V on the MMI scale. Due to the earthquake, the building suffered slight damages with small cracks seen on its exterior infill walls and spalling of plaster is also seen in some places.

Minor damage of the beam column joints is also observed. A damage of 20% (G1) is assigned to the building according to the damage percentages adopted. The structure (Fig.3a and Fig.3b) is a four storeyed moment frame school building in Turkey. It is located at a distance of 17.2 km from the epicenter of the Bingol earthquake 2003 with a local intensity of VIII MMI.

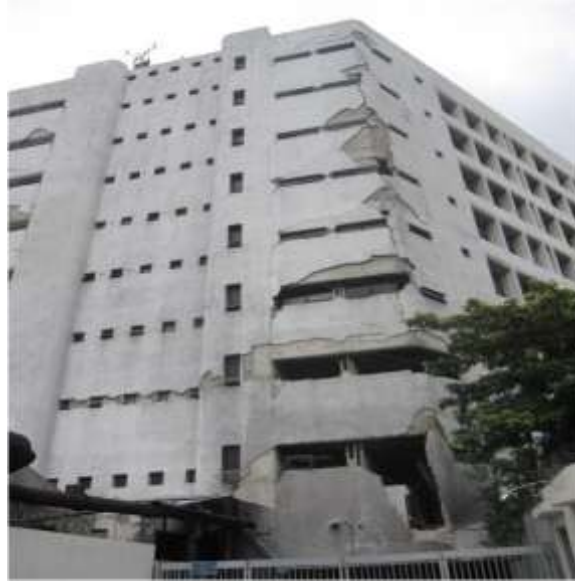
Fig. 4a: Exterior damage to the teleco building, Haiti

The earthquake had a Moment Magnitude of $6.4 M_w$. Due to the earthquake, the building suffered minor cracks and spalling of concrete. There was considerable crushing of concrete in the shear walls. A damage of 30% (G2) was assigned. The structures (Fig. 4a, Fig. 4b) are an eight storeyed V-shaped shear wall building in Port-au-Prince, Haiti. It is located at a distance of 24 km from the epicenter of the Haiti 2010 earthquake with a local intensity of VIII MMI. The earthquake had a Moment Magnitude of $7 M_w$. This earthquake caused severe damages to life and property. The building shown in the fig. 4 suffered major damages due to the earthquake. Both the structural and non-structural components underwent extensive damage.

Most of the damage is seen in the second and the third floors including shear cracking of columns, failure of concrete cores, damage of column bases and unreinforced non-structural walls etc. A damage of 45% (G4) was assigned. The structure (Fig. 5) is a two storeyed building in Rasht, Iran. It is located at a distance of 40 km from the epicenter of the Northern Iran 1990 earthquake with a local intensity of VI MMI. The earthquake had a Moment magnitude of 7.7. Due to the earthquake, it suffered major damages. The infill walls on both the floors completely collapsed along with cracking of the interior walls. A damage of 70% (G4) was assigned to the building.

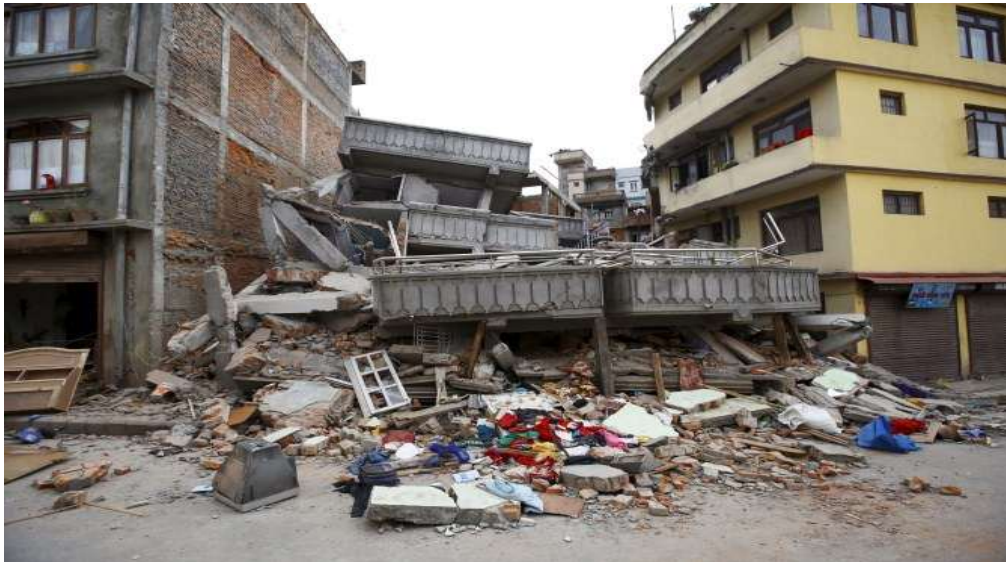
Fig. 6: Complete collapse of a residential building due to Nepal 2015 Earthquake

The structure (Fig. 6) is a three storeyed residential building in Kathmandu. It is located at a distance of 80 km from the epicenter of the $7.8 M_w$ Nepal earthquake 2015 with local intensity of IX MMI. Due to the earthquake, the building completely collapsed leading to 100% (G5) damage. Most of the buildings in the surrounding area also suffered similar damage. It is generally noticed that buildings having more than 40% damage are not in a useable condition.

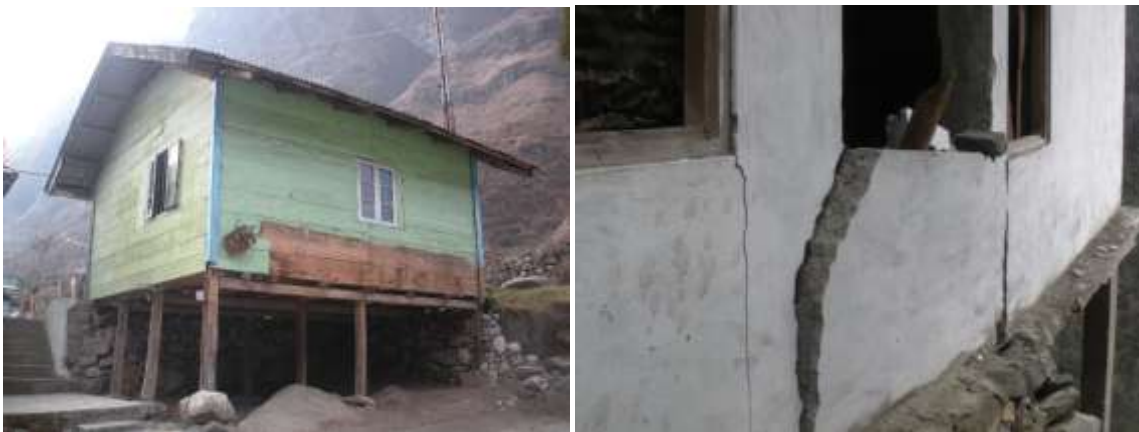
Fig. 7: Buildings status soon after Sikkim 2011 earthquake; (a) Constructed in traditional techniques and locally available material and (b) Constructed by modern material without engineering considerations

Data analysis and models: Most of the time, engineered structures remain largely undamaged or slightly damaged. Non-engineered structures including mud or buildings constructed using local materials are heavily damaged due to earthquakes. Field investigation of the first author soon after Sikkim 2011 earthquake of magnitude $6.9 M_w$ found that buildings constructed with traditional techniques using locally available material i.e. wooden floor separated by wooden beam rollers etc. are intact and structures with engineered materials but poor engineering construction i.e. poorly constructed concrete frame structures were affected severely. Figure 7 shows buildings from same location (a) constructed in traditional techniques and locally available material and (b) constructed by modern materials without

proper engineering construction practices. Data generated here consist of mud buildings and modern buildings, though non-engineered and are referred cumulatively as non-engineered structures.

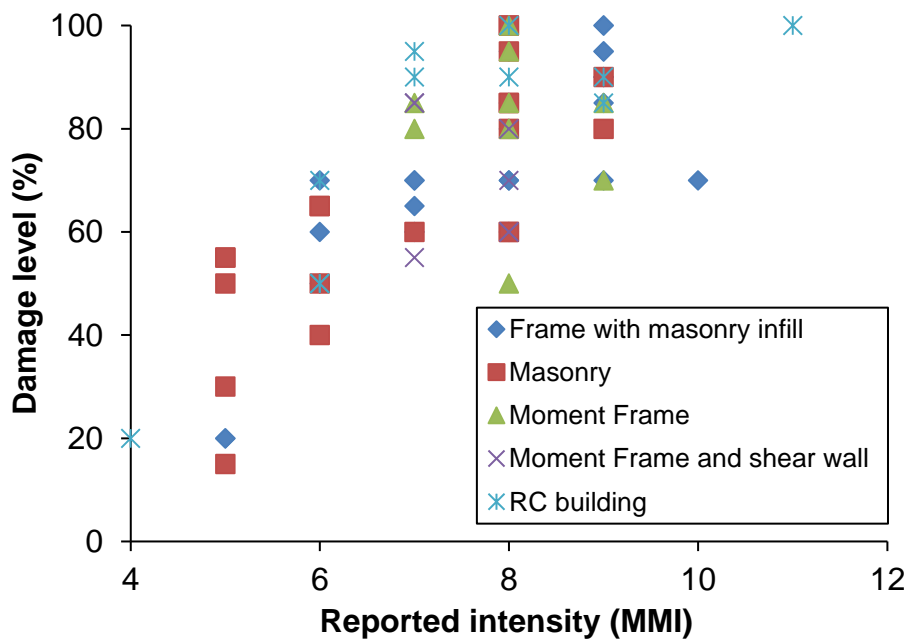
Fig. 8: Data considered in the study for different building type.

It is to be noted that the term non-engineered has been applied to all the structures that have failed during the considered earthquakes within their design life and hence collected data are assigned a level of damage based on damage descriptions. Figure 8 shows complied data for different earthquake types. The general trend shows the intuitive trend of an increase in intensity and increase in damage level irrespective of earthquake type. It is also observed that the damages based on the building types follow a trend except for the most of structures type with moderate positive correlation coefficient.

Structures constructed as moment resisting frames with reinforced concrete do not follow trend with intensity values which may be attributed by the dearth of data. Data complied is also checked for relating the age of the structure with the damage level and in the absence of data proves ineffective. It may be appropriate to report building type with the representative age while reporting building damages due to earthquakes. Similar buildings in the same location with different age may show different seismic damage level. It is also noted here that there are many exogenous variables including time period of the structure, site class, building configuration etc. that effect the response of structures and are not included in this present study.

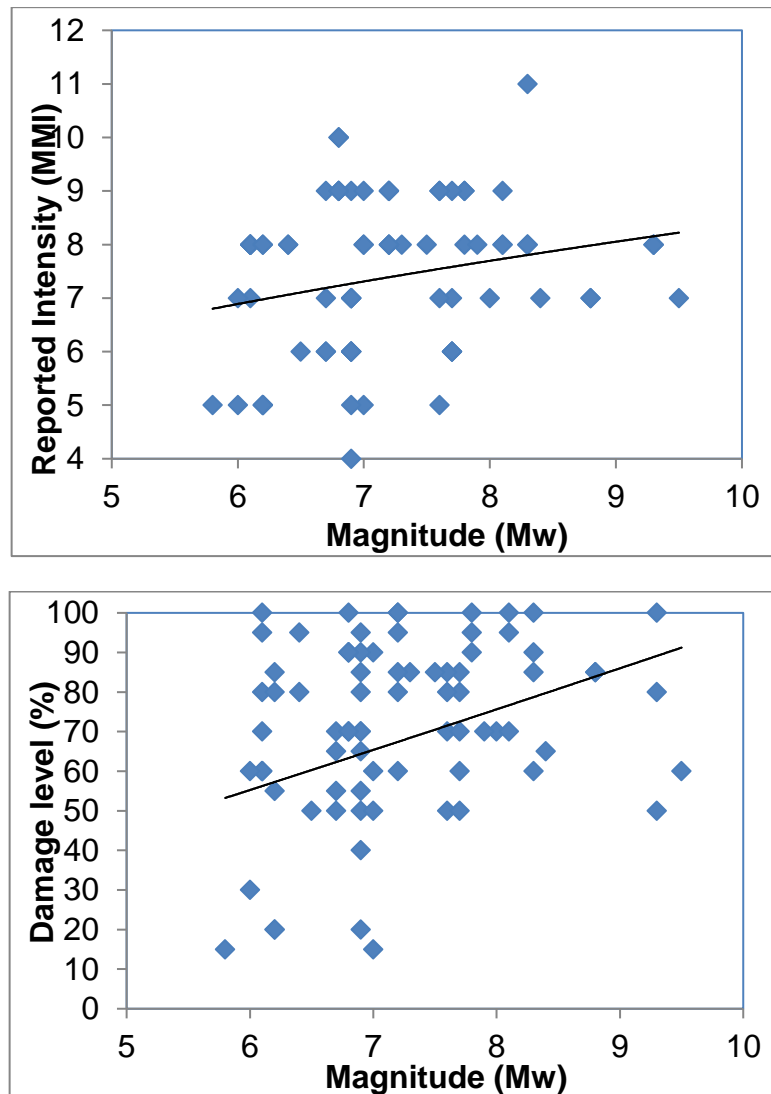
Fig. 9: Intensity and damage level versus magnitude of data used in the study

The proposed damage percentages are correlated with the reported intensities and hypocentral distances. The intensities are reported in Modified Mercalli Intensity (MMI) scale and the hypocentral distances are represented in km. Data is studied by plotting intensity and damage level with magnitude (Figure 9) and intensity and damage level with hypocentral distance (Figure 10). It is observed that increase in magnitude shows an increase in the intensity and damage level and at the same time increase in distance shows a decrease in damage level and intensity. It is noted this could be due to the abundance of near field data and lack of far field data where site effects due to the local soil conditions play a major role in aggravating the ground shaking hazard at larger distances.

Figure 9 shows that the earthquake magnitudes range between 5.5 Mw and 9.5 Mw and observed weak correlation between these two parameters. This may be due to the non-consideration of the hypocentral distances of the locations. Similar observation was also noticed in figure 10 when hypocentral distance is plotted with intensity and damage level. Here intensity and hypocentral distance are taken as independent parameters and the damage level is taking as dependent parameter for model development. Linear regression analysis of these parameters are performed for the different type of earthquakes separately and also analysed for all data together to understand relationship between damage level in percentage and the earthquake parameters of intensity (MMI) and hypocentral distance (km) by following below equation form.

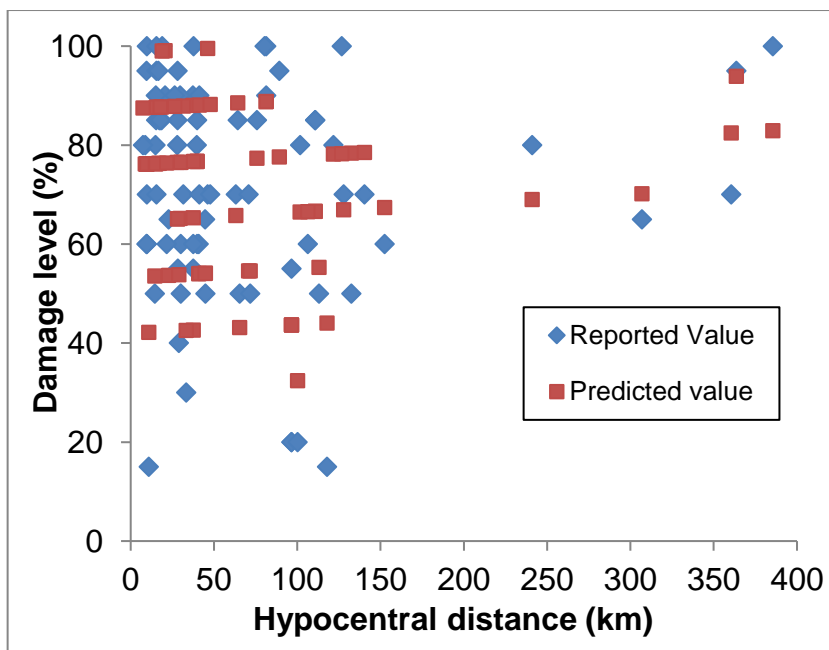
Fig. 11: Typical plot of data and predicted model plot – All data damage level with hypocentral distance.

Multiple regression analysis for different earthquake types is done to predict the damage level (in percentage) of structures in terms of local intensities (MMI) and the hypocentral distances and also to find their individual influence on the damage of structures. Coefficients ‘a’ and ‘b’ corresponding to 95% confidence interval are obtained and shown in table 3 for the general form of equation (1) given above. Typical figure for all data showing the variation of the damage level with hypocentral distance and damage level with reported intensity are given in figure 11 and figure 12 respectively. Models for different earthquake type are given in table 3.

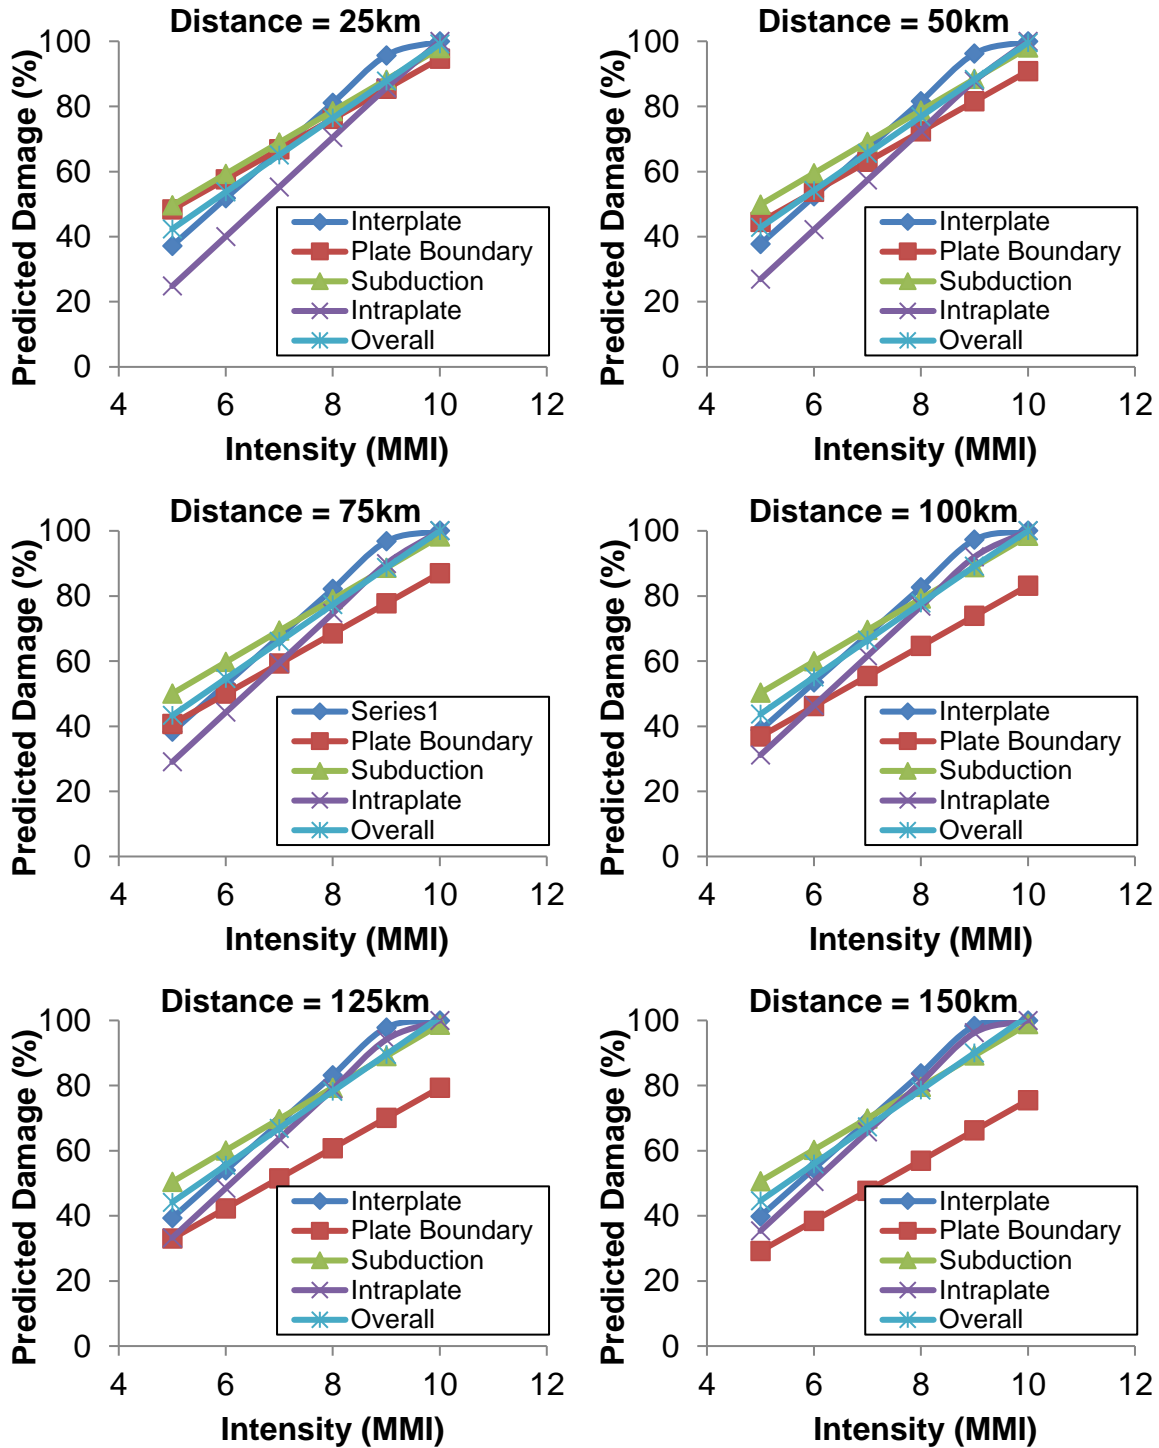
Fig. 14: Comparison of damage level for different type of earthquake by varying intensities and hypocentral distance

Damage level prediction for each type of earthquake at specific hypocentral distance is compared in figure 14. The damage level was predicted from the model for various intensities (MMI) while keeping the hypocentral distance of the buildings constant (plot has been generated for 25 to 150 km with increment of 50 km). This study shows that intensity of V and above caused damage level of 30 to 50% to non-engineered structures. The extents of damage to buildings are almost similar in shorter hypocentral distances of up to 100 irrespective of earthquake type.

We can also see that for shorter distances (25 km), the damage suffered by buildings in subduction earthquakes is higher compared to the other types and those by intraplate earthquakes are the least. This could be attributed to the high magnitude of most of the subduction earthquakes. Also, for larger distances, the damage suffered by buildings in interplate earthquakes is higher and those by plate boundary earthquakes are the least. Damage level reported by plate boundary earthquakes generally shows lesser damage levels than other earthquake types.

From figure 14 it can also be observed that for almost all the earthquake types due to the high dominance of near field earthquake data, the predicted damage level is decreasing with increase in hypocentral distance of the buildings, for a given intensity value in turn not accounting the site effects at larger distances. It is to be noted that the site effect will play a major role in the modification of the seismic waves through the deposit, but since the intensity is a measure of the felt hazard at the soil stratum, the site effects are assumed to be incorporated while performing the regression to obtain the equation.
