Classification of road damage due to earthquakes

Abstract Earthquakes cause massive road damage which in turn causes adverse effects on the society. Previous studies have quantified the damage caused to residential and commercial buildings; however, not many studies have been conducted to quantify road damage caused by earthquakes. In this study, an attempt has been made to propose a new scale to classify and quantify the road damage due to earthquakes based on the data collected from major earthquakes in the past. The proposed classification for road damage due to earthquake is called as road damage scale (RDS). Earthquake details such as magnitude, distance of road damage from the epicenter, focal depth, and photographs of damaged roads have been collected from various sources with reported modified Mercalli intensity (MMI). The widely used MMI scale is found to be inadequate to clearly define the road damage. The proposed RDS is applied to various reported road damage and reclassified as per RDS. The correlation between RDS and earthquake parameters of magnitude, epicenter distance, hypocenter distance, and combination of magnitude with epicenter and hypocenter distance has bee

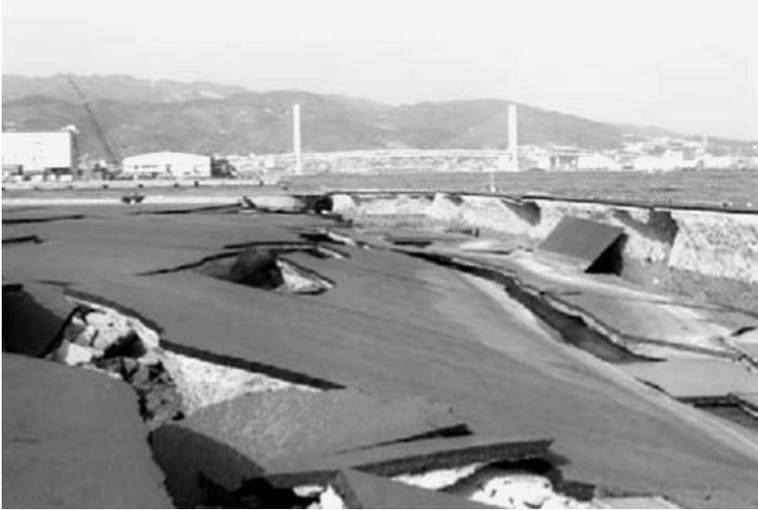
Fig. 1 Road structure collapse due to Kobe earthquake (Tung 2004)

Eight roads were damaged extensively due to different earthquakes, and these roads were completely inaccessible. Complete collapse of road structure due to the Great Hanshin earthquake or Kobe earthquake that occurred on January 17, 1995, is shown in Fig. 1. The moment magnitude of earthquake was 6.9, focal depth was 16 km, and the epicenter distance was 20 km from the damage site at Awaji Island. The reported MMI scale is X (Tung 2004). The damage and blockage of a road due to Atico Peru earthquake June 23, 2001, is shown in Fig. 2. The reported earthquake had a magnitude of 8.4 (M_w) and a focal depth of 33 km. The damage site was 25 km from the epicenter and reported MMI scale value is XII (ASCE-TCLEE 2001). The damage to a road in Southern Peru due to the Peru earthquake on August 15, 2007, is shown in Fig. 3. Earthquake magnitude of 8.0 (M_w) and focal depth of 39 km were reported, and the damage site was about 30 km from the epicenter. MMI scale of XI was reported (EERI Special Report 2007). The road embankment failure on the Pan-American Highway due to the Peru earthquake that occurred on August 15, 2007, is shown in Fig. 4. The earthquake magnitude of 8.0 (M_w) scale with a PGA above 0.6 g was reported. The damage road was 190 km from epicenter. The reported MMI scale is XI (MCEER 2007). The road damaged and blocked due to the earthquake at Balakot in Pakistan that occurred on October 8, 2005, is shown in Fig. 5. The reported earthquake magnitude was 7.6 in M_w and a focal depth of 10 km. The damage site was about 30 km to the north from the epicenter. The reported MMI scale is X (Navin and Matthew 2006). This earthquake has also damaged the road (see Fig. 6) located 30 km to the east of epicenter due to the collapse of retaining wall. Thursday, March 24, 2011, a powerful earthquake moment magnitude of 6.8 has rocked far-eastern Myanmar. The quake struck at a depth of 10 km and epicenter located at 20.705°N, 99.949°E, according to the USGS (2011c). This earthquake damaged roads and bridges; Fig. 7 shows

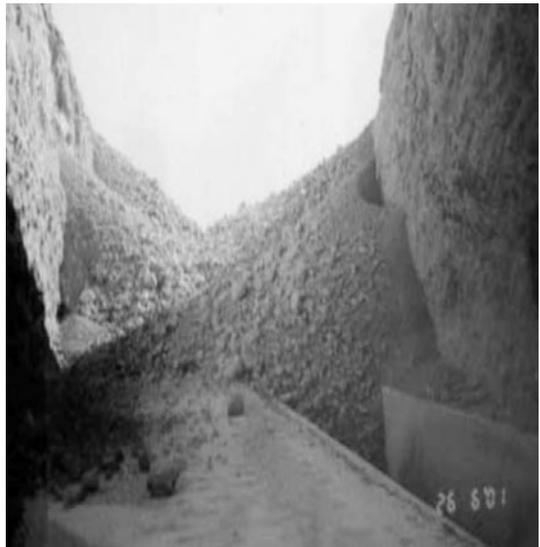
Fig. 2 Landslide blockage of supply canal (Yashinsky) due to Peru earthquake (ASCE-TCLEE 2001)

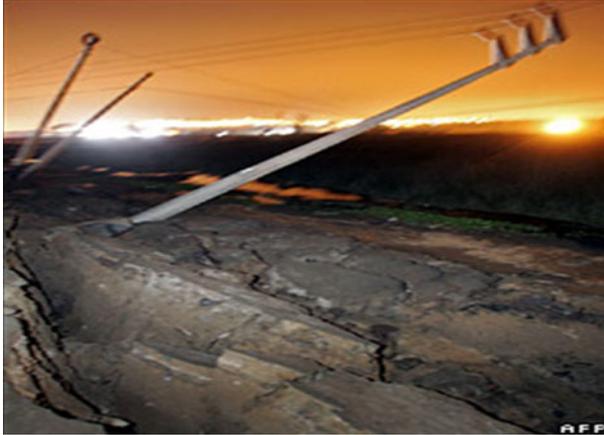
Fig. 3 A damaged road in Southern Peru due to Peru earthquake (EERI Special Report 2007)

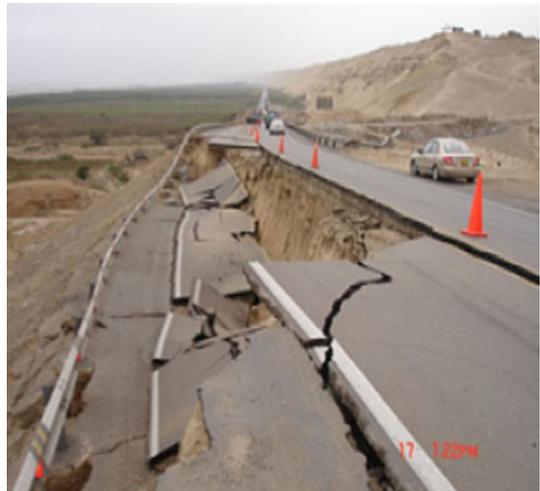
Fig. 4 Pan-American Highway damage near the Pacific Ocean due to Peru earthquake (MCEER 2007)

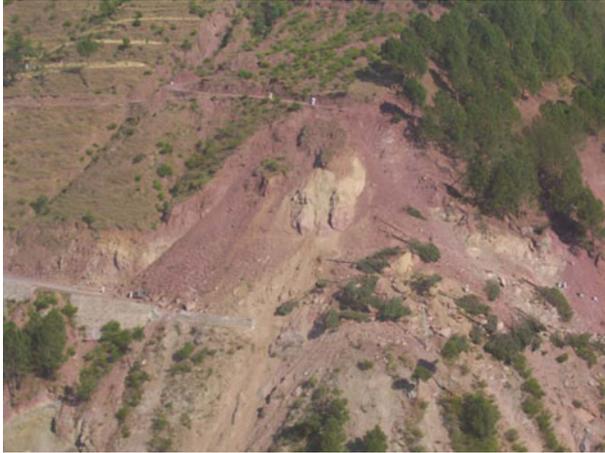
Fig. 5 Road blocked due to Pakistan earthquake (Navin and Matthew 2006)

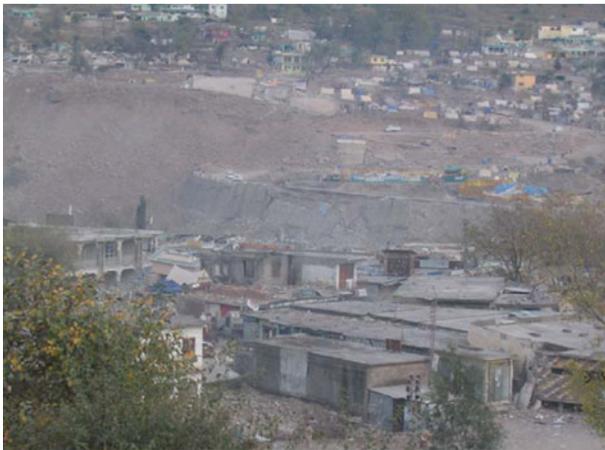
Fig. 6 Collapsed road east of the epicenter due to Pakistan earthquake (Navin and Matthew 2006)

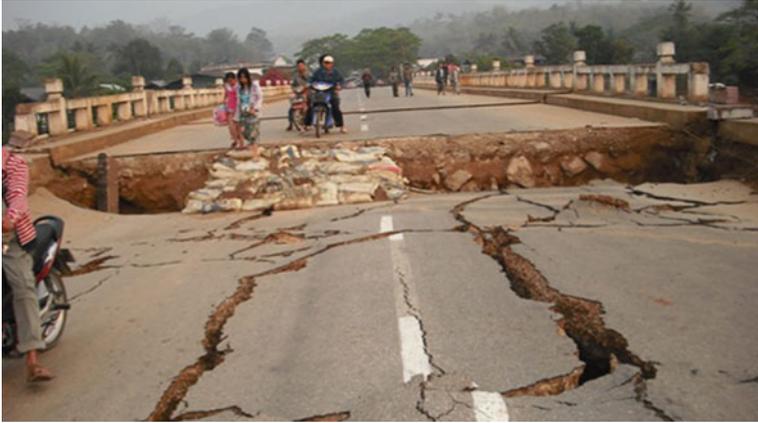
Fig. 7 Damage of bridge approach road due to Myanmar (Burma) earthquake 2001 (CBC 2011)

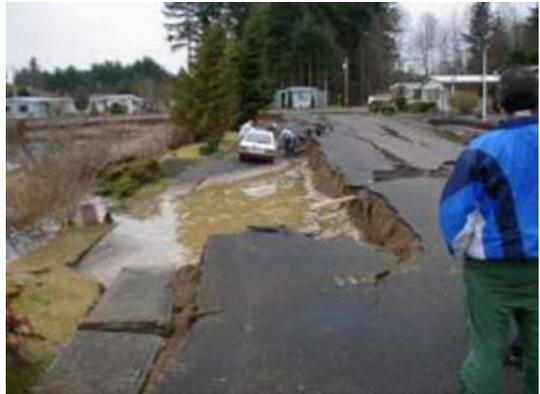
Fig. 8 Road damage at Sunset Lake, Tumwater, from the 2001 Nisqually earthquake [Photo: Steven Kramer/University of Washington accessed in Washington DNR (2011)]

damaged road at Tarlay, Burma and this road is about 29 km from the epicenter. Damages also reported in Tachileik, Naryaung, and Monglin (FEWW 2011), but limited details about the road damages are available. Severe damage to moderate damage of roads was reported during 2001 Nisqually earthquake, Washington. The Nisqually earthquake was an intraslab earthquake that occurred on February 28, 2001, and was one of the largest recorded earthquakes in Washington State. Earthquake moment magnitude of 6.8 was reported with MMI of VIII and less. Most of the property damages occurred at a distance nearer to the epicenter (Wikipedia 2010a). Severely damaged road is shown in Fig. 8.

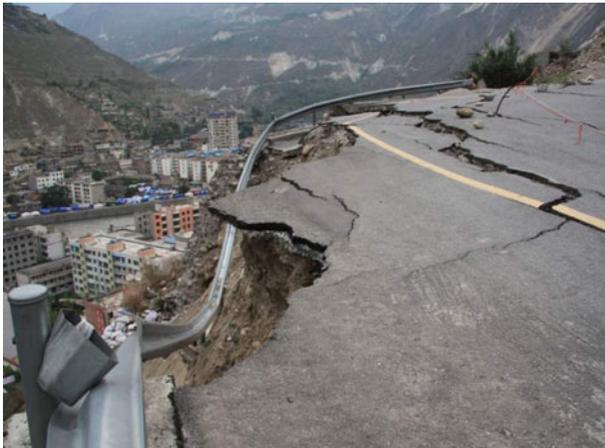
Fig. 9 Road damage in Yingxiu due to Wenchuan earthquake (Zifa 2008)

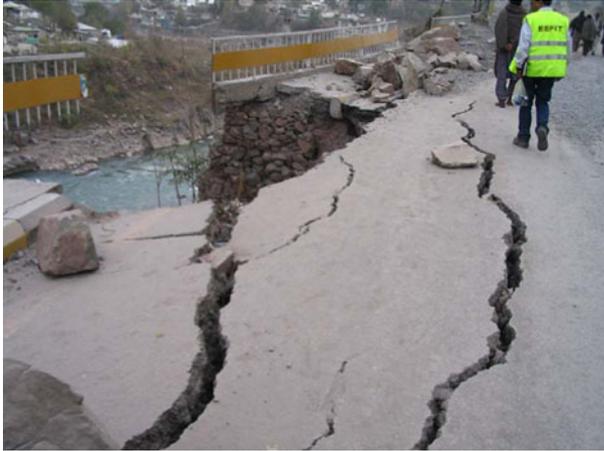
Fig. 10 Damage of road due to Muzaffarabad earthquake (Navin and Matthew 2006)

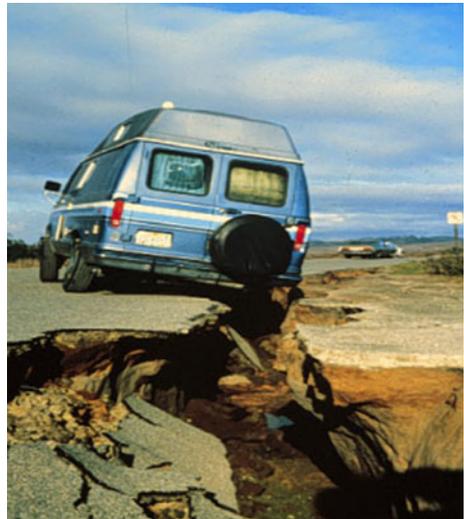
Fig. 11 Road damage due to Loma Prieta earthquake (EARTHQUAKES, Marshall et al. 1989)

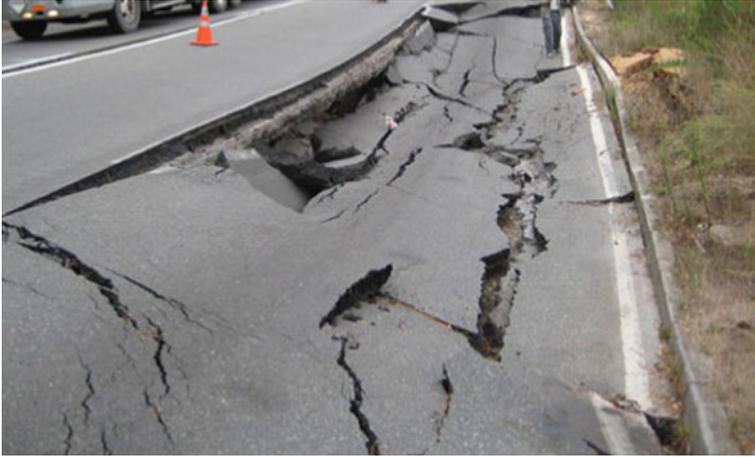
Fig. 12 Damaged road due to Chile earthquake 2010 (Photo: <http://news.bbc.co.uk/2/hi/americas/8542112.stm>)

site. The reported MMI is VIII (Marshall et al. 1989). Highly damaged road due to Chile earthquake 2010 is shown in Fig. 12. A moment magnitude of 8.8 occurred on February 27, 2010, at Chile and was called as Chile earthquake. Epicenter location was located off the coast of either the Maule Region or the Biobío Region of Chile (Wikipedia 2011a). This earthquake caused damage of VIII and above in MMI and also triggered a tsunami which devastated several coastal towns in south-central Chile and damaged the port at Talcahuano (Fig. 13). Many roads were damaged and blocked for emergency operation due to tsunami alert. Sichuan earthquake is popularly known as Great Sichuan earthquake or 2008 Sichuan earthquake and also the Wenchuan earthquake. The epicenter was located at 30.986°N , 103.364°E , i.e., 80 km west-northwest of Chengdu, the capital of Sichuan, with a focal depth of 19 km (USGS 2008). Massive landslide was reported at Qingchuan and more than 700 people were dead. A train was buried by a landslide near Longnan,

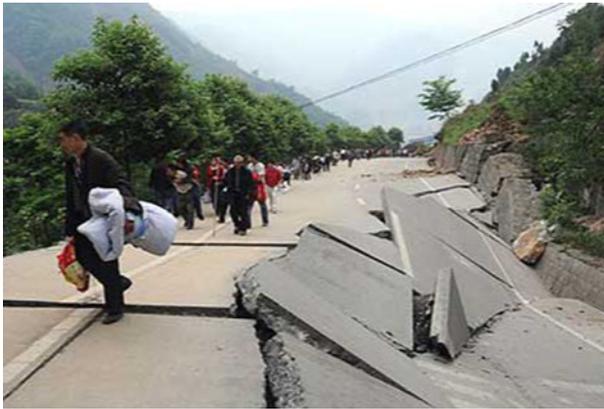
Fig. 13 Damaged road due to Great Sichuan earthquake 2008 (Photo: <http://www.mirror.co.uk/news/top-stories/2008/05/14/china-earthquake-death-toll-may-reach-50-000-115875-20417082/>)

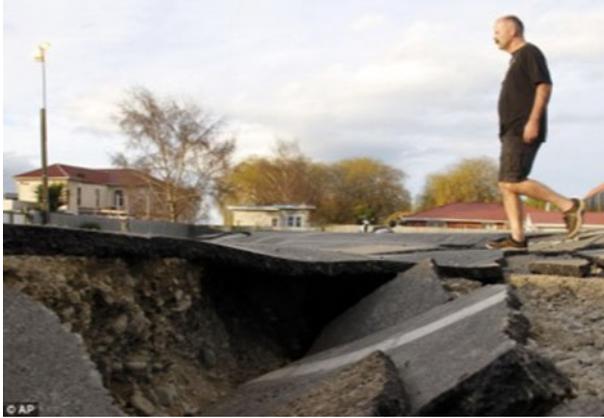
Fig. 14 Damaged road due to Canterbury earthquake 2010 (Photo: <http://archive.wn.com/2011/03/07/1400/worldnaturaldisaster/>)

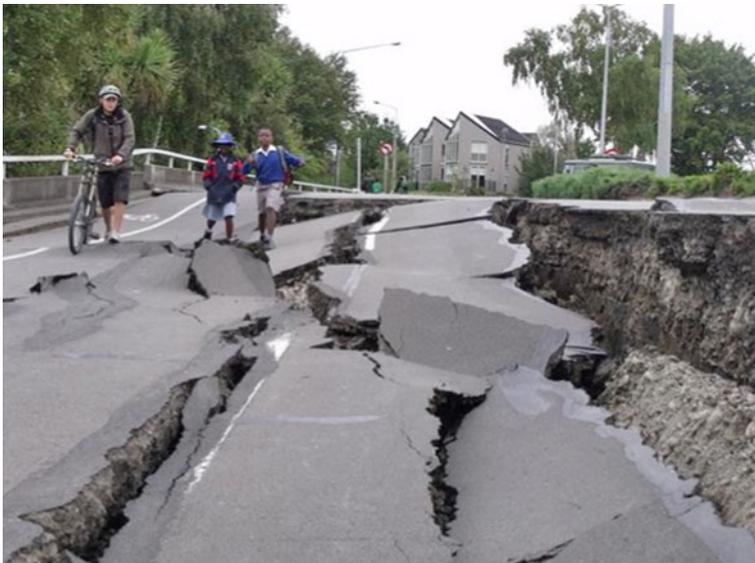
Fig. 15 Damaged road due to Christchurch earthquake (Photo: <http://eqchch.wordpress.com/2011/02/25/canterbury-christchurch-earthquake-damage-2011/>)

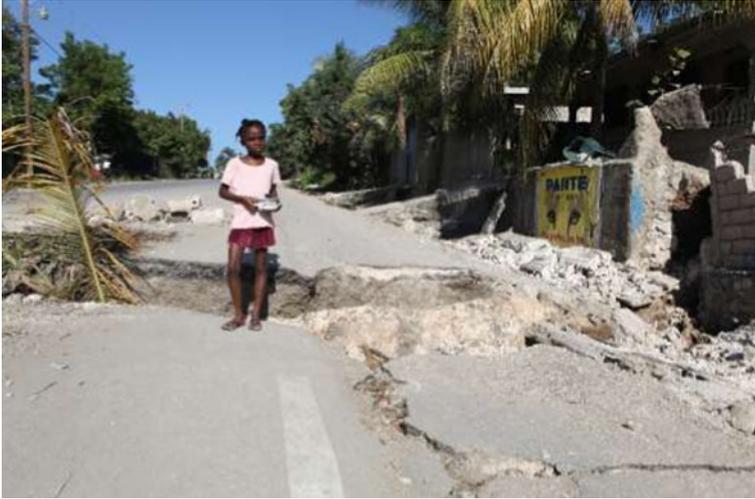
Fig. 16 Damaged road due to 2010 Haiti earthquake (Photo: http://gallery.usgs.gov/photos/02_24_2010_c28Ja44Yyt_02_24_2010_6)

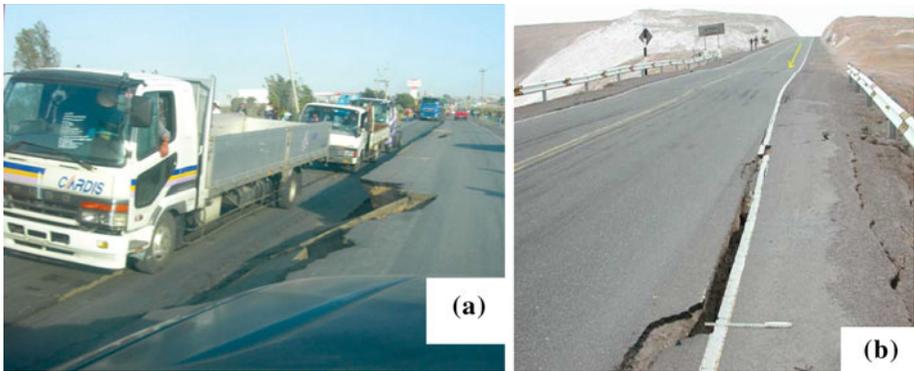
Fig. 18 Damaged roads due to Peru earthquake 2007 (Photo: **a** Pan-American Highway (MCEER 2007) and **b** Highway damage (GEER 2008))

shown in Fig. 18a, b. The earthquake had a magnitude of 8.0 in M_w and damaged site was located 220 km from the epicenter. The reported MMI scale for the same is XI (MCEER 2007). The damage site (Fig. 18b) was at a distance of 200 km from the epicenter. The reported MMI value is XI (GEER 2008). Partially blocked and damaged road due to rock slide during June 23, 2001, Atico, Peru earthquake is shown in Fig. 19. The earthquake had a magnitude of 8.4 in M_w and epicenter was about 150–300 km from the damaged site. The reported MMI for the same is XII (ASCE-TCLEE 2001). Approach road settlement at Koshino Bridge due to the earthquake on October 23, 2004, at central (Chuetsu) region of Niigata Prefecture is shown in Fig. 20. The earthquake had a magnitude of 7.0 in M_w , and the epicenter was close to the damage site and the reported MMI for the same is IX (Shanmuganathan 2005). Crack on the road traversing the flexural scarp due to the December 26, 2003, Bam City, Iran earthquake is shown in Fig. 21. The earthquake had a

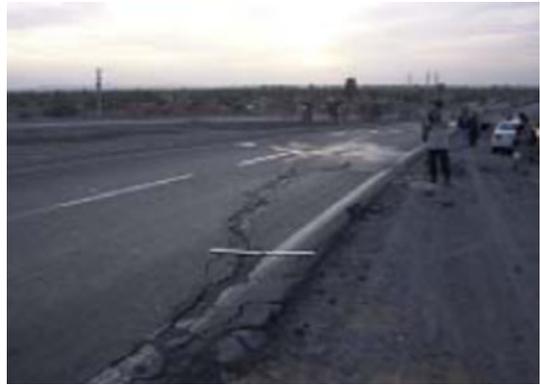
Fig. 22 Severe defect on road surface due to Hokkaido Toho-Oki earthquake (Tung 2004)

road surface due to Hokkaido Toho-Oki earthquake of Japan, 1994, is shown in Fig. 22. The earthquake had a magnitude of 7.7 in Mw and epicenter was reportedly close to the damage site. The reported MMI scale for the same is VII (Tung 2004). The Boston–Jasenovik road was damaged in some parts and ditches were covered with stones and earth due to the April 24, 2002, Gjilan/Gnjilane Region earthquake as shown in Fig. 23. It had a magnitude of 5.7 in Mw and epicenter was close to the damage site. The reported MMI scale for the same is VII (IMC 2002). The road damage due to slumping on Route 9N near Clintonville, Clinton County, NY due to April 20, 2002, Au Sable Forks, New York earthquake is shown in Fig. 24. The earthquake had a magnitude of 5.3 in Mw, and the epicenter was about 8 km from the damaged road and the reported MMI scale for the same is VI (Young Kim 2002). Chile earthquake 2010 caused moderate damage to roads located at 215 km away from epicenter. Figure 25 shows the image of moderately damaged road due to Chile earthquake 2010. Canterbury earthquake 2010 had also caused moderate damage close to epicenter apart from high damage. Figure 26 shows damaged road image close to epicenter due to Canterbury earthquake 2010. Nisqually earthquake 2001 not only caused extensive damage but also moderate damage to many roads. Figure 27 shows image of moderately damaged road due to 2001 Nisqually earthquake.

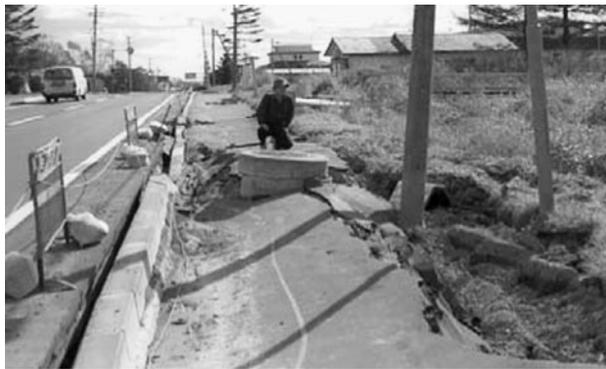
Fig. 23 Bostan–Jasenovik road is damaged in some parts and ditches are covered with stones and earth (EDARP 2002)

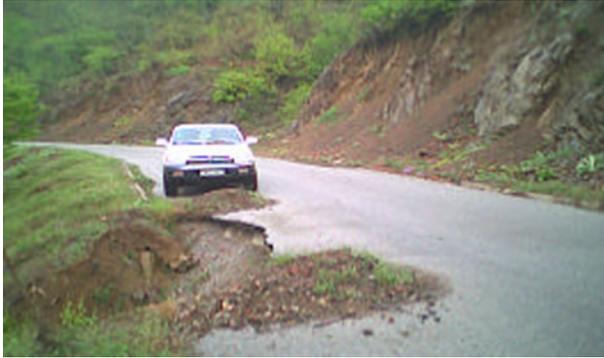
Fig. 24 Road damage due to slumping on Route 9N near Clintonville, Clinton County, NY due to New York earthquake (Young Kim 2002)

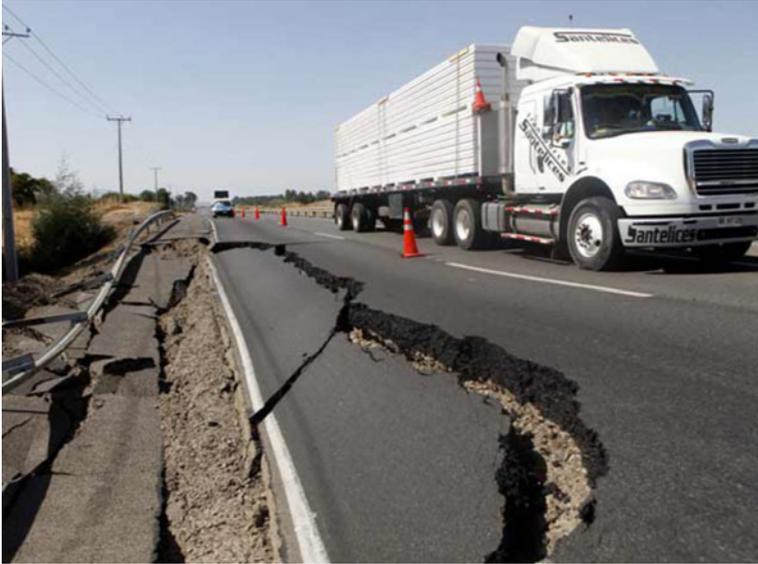
Fig. 25 Road damage due to Chile earthquake 2010 (Photo: http://www.channelnewsasia.com/photosgallery/gallery_20100228095431.htm)

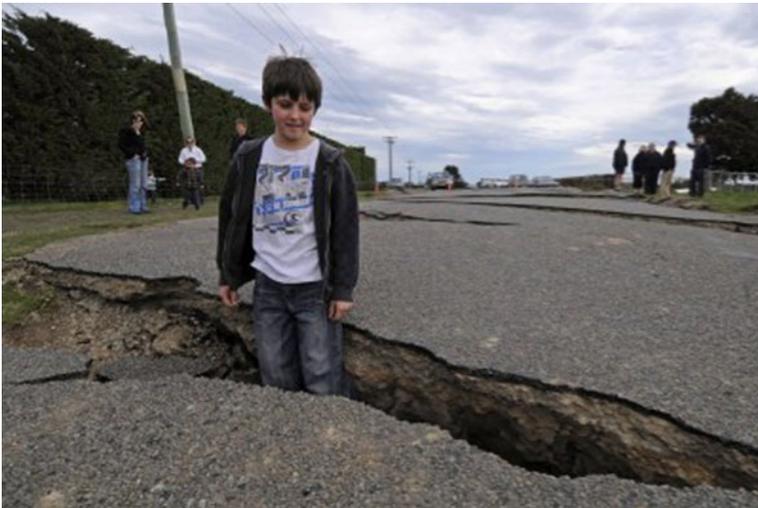
Fig. 26 Damaged road due to Canterbury earthquake 2010 (Photo: <http://www.natural-calamity.info/earthquake-destroyed-about-500-buildings-in-chrishchurch/>)

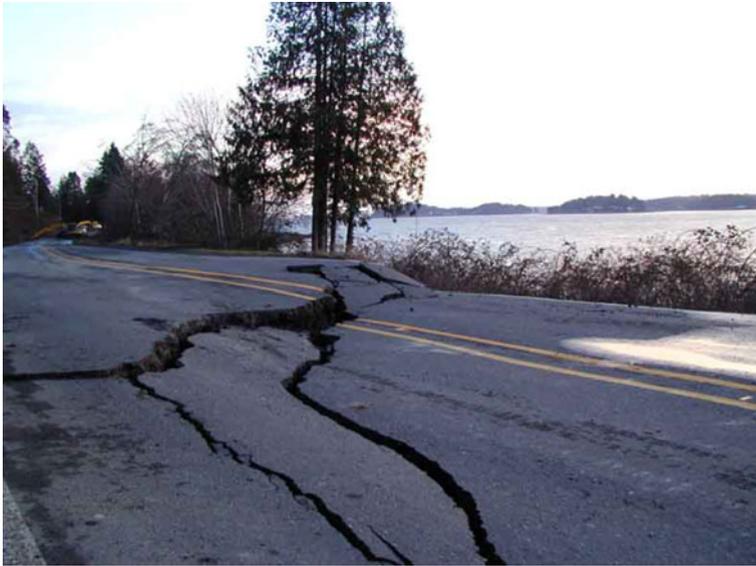
Fig. 27 Road damage at Sunset Lake, Tumwater, from the 2001 Nisqually earthquake (Photo: http://en.wikipedia.org/wiki/2001_Nisqually_earthquake)

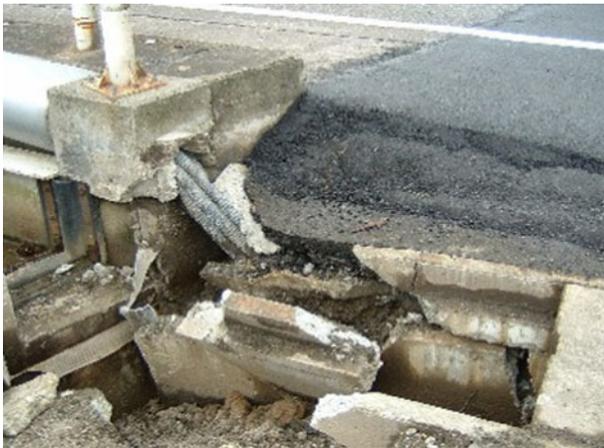
Fig. 28 Approach road settlement at Hurumiya Bridge (Shanmuganathan 2005)

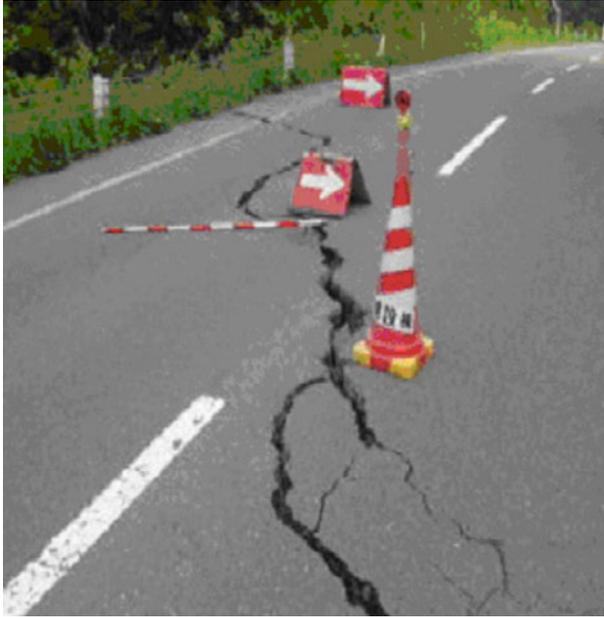
Fig. 29 Cracks of Route 397 in Ohfunato due to Miyagi-Oki earthquake (DCRC 2003)

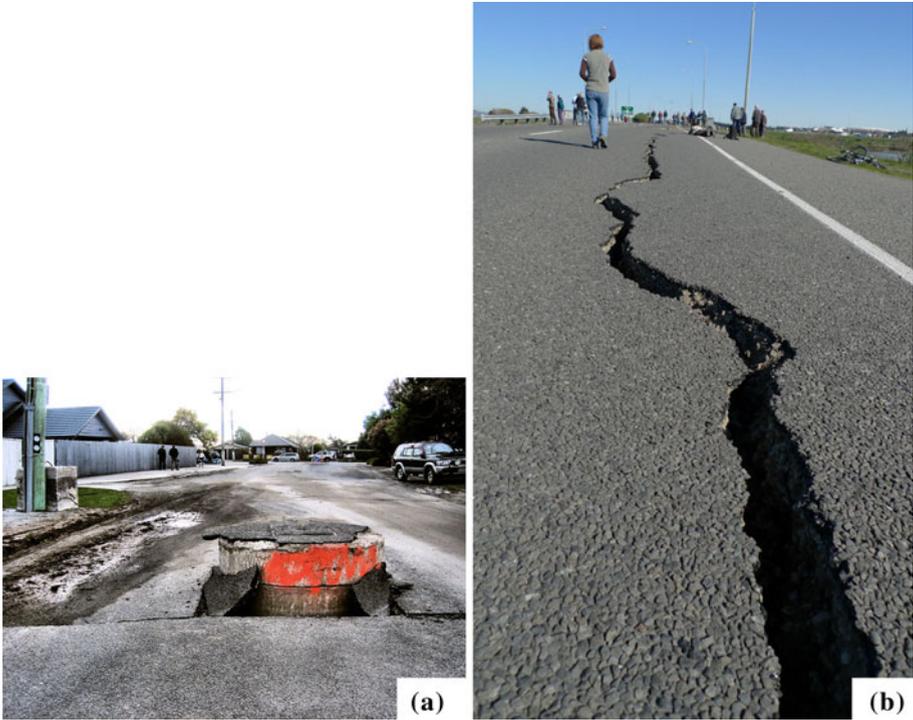
Fig. 30 Low to moderate damaged roads due to 2010 Canterbury earthquake (Photo: http://en.wikipedia.org/wiki/2010_Canterbury_earthquake)

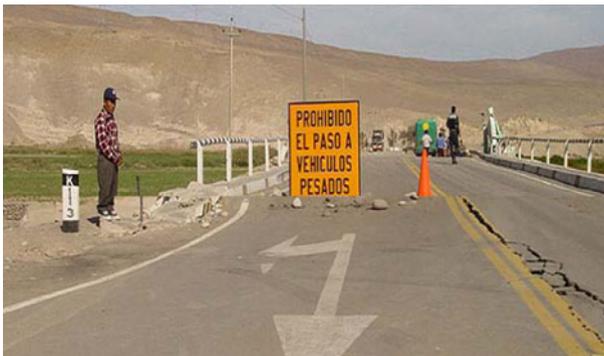
Fig. 31 Settlement of bridge approach and cracking of road. Only one lane is open for traffic (Nakamura 2000)

Roads suffering low to slight damages are reported in this section. The settlement of bridge approach and cracking of road due to June 23, 2001, Atico earthquake in Peru is shown in

Fig. 31. The earthquake had a M_w of 8.4 and the epicenter was at a distance of about 150 to 300 km from the damaged road. The reported MMI value is XII (Nakamura 2000). The damage to road due to the Tokachi-oki earthquake on September 26, 2003, is shown in Fig. 32. The earthquake had a magnitude of 8.1 in M_w and epicenter was about 150 km to 300 km from the damage site. Reported MMI value is XII (Tung 2004).

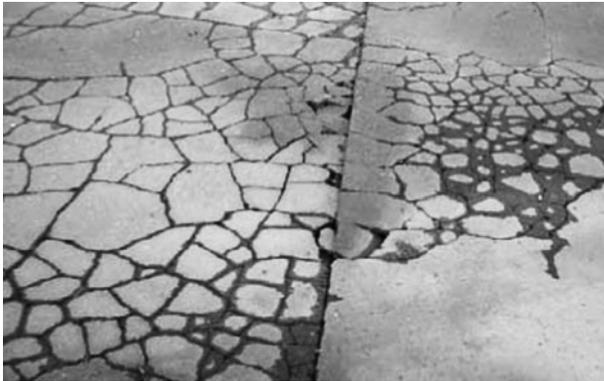
Fig. 32 Minor cracks on road surface due to Tokachi-Oki earthquake (Tung 2004)
