White-topping, 'a real steal'

Bangalore Mirror Bureau / Apr 4, 2022, 06.00 AM IST

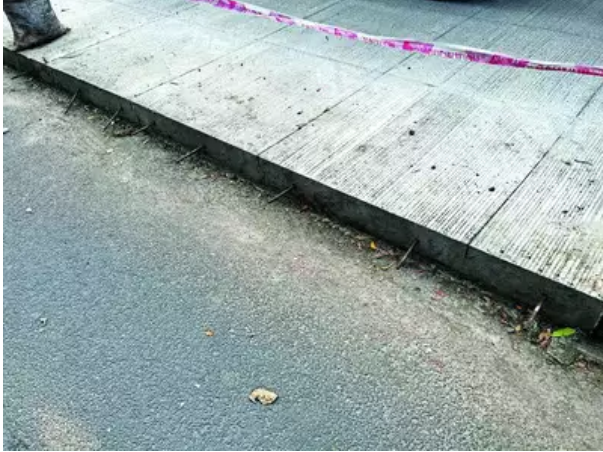
*Close up of a whitetopped section in Koramangala.*

They alleged the stretch is being white-topped without including the essential tie bars. Residents also pointed out, on the contrary, the said tie bars are visible in white-topping work underway in Koramangala and Indiranagar.

"There is no steel reinforcement anywhere in the concrete slabs, including the joints. Normally, steel bars are provided at the joints so that the slabs behave as a single unit. White-topping work in Indiranagar and Koramangala have these bars sticking out of concrete slabs.

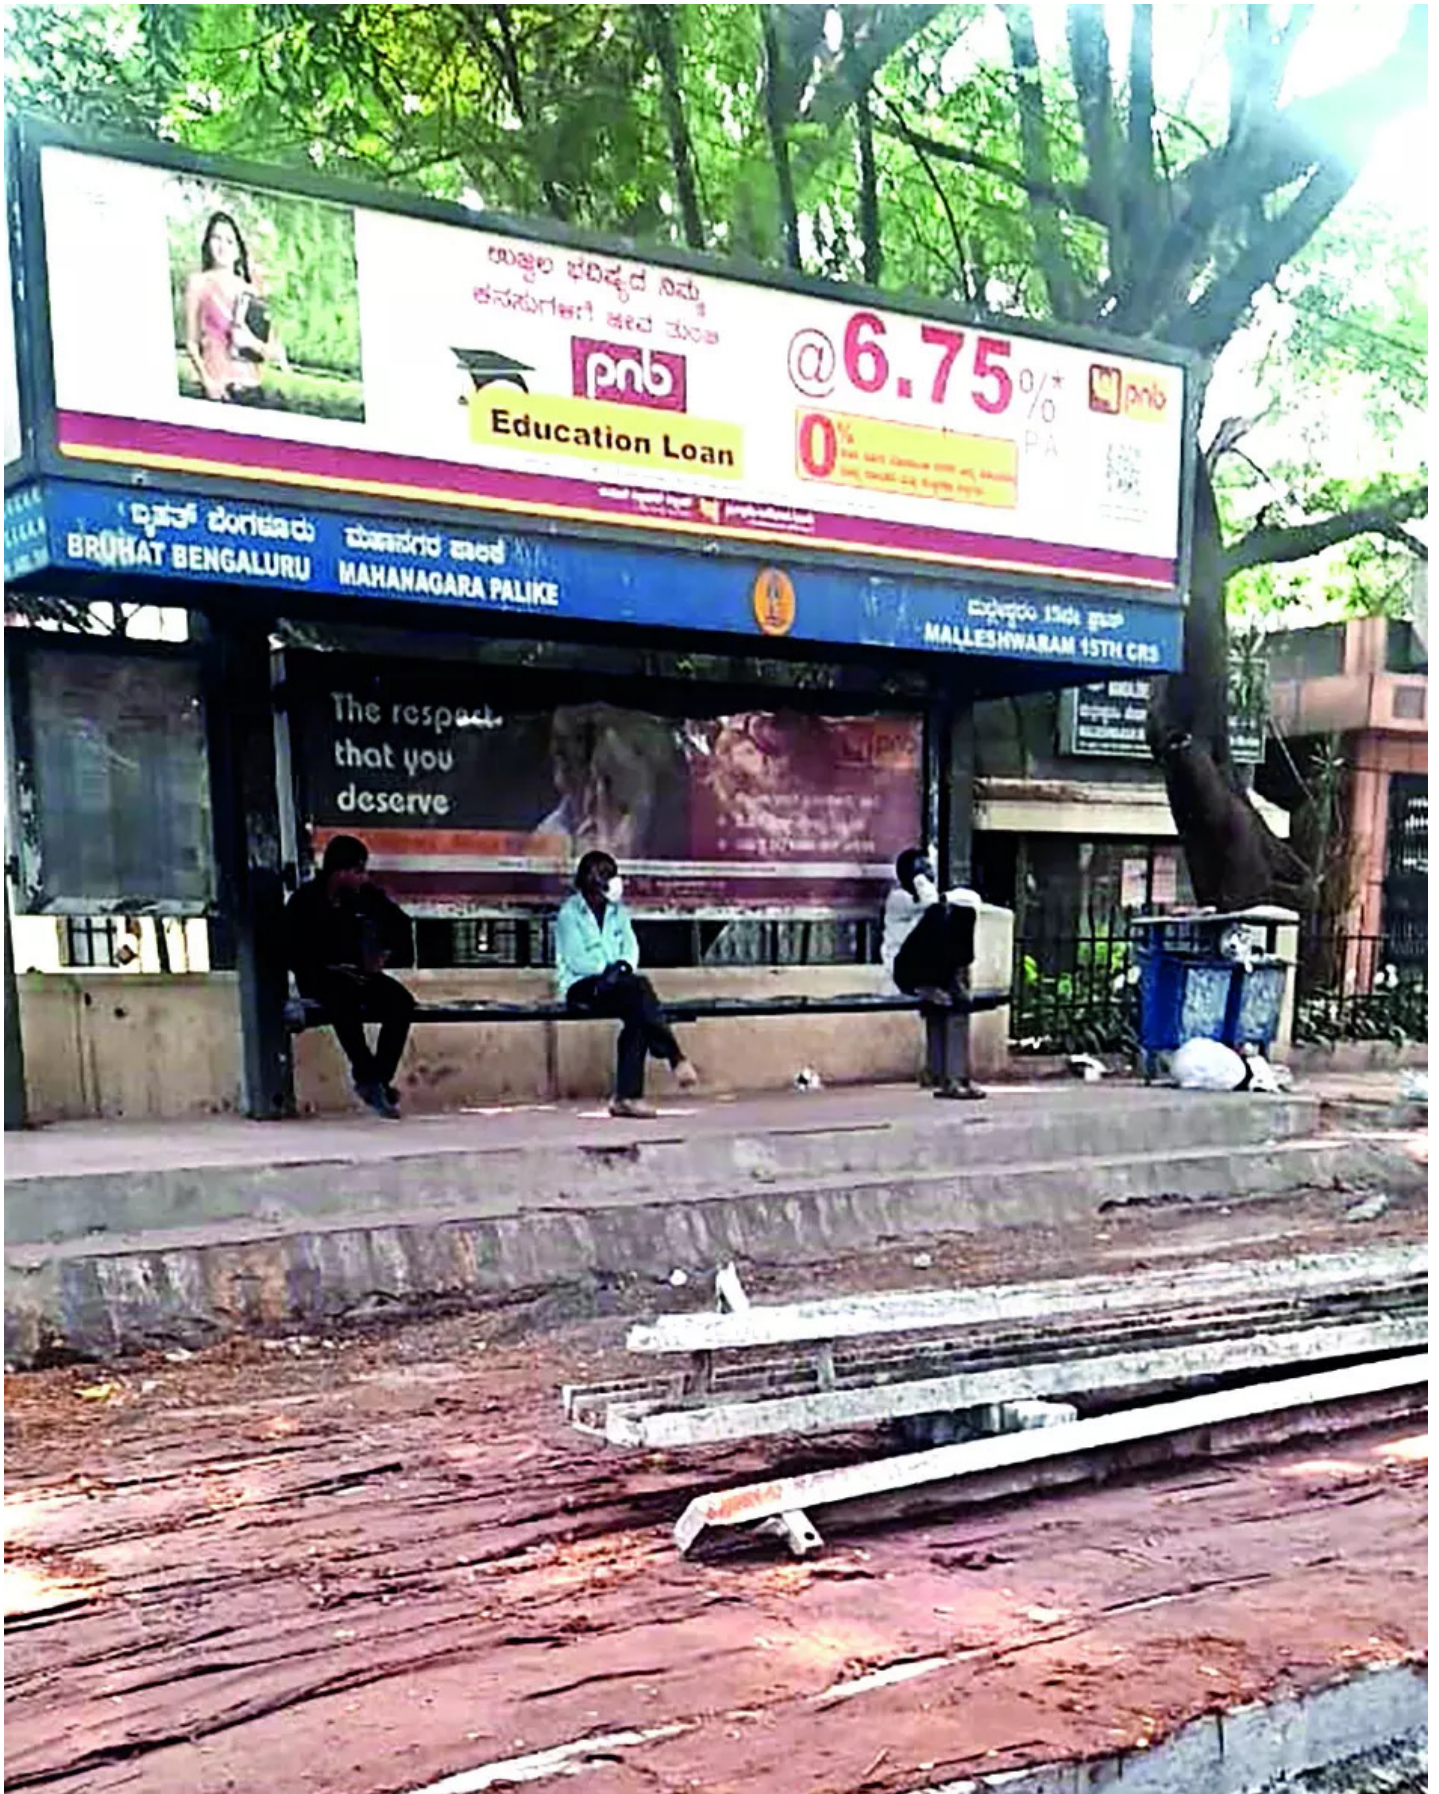
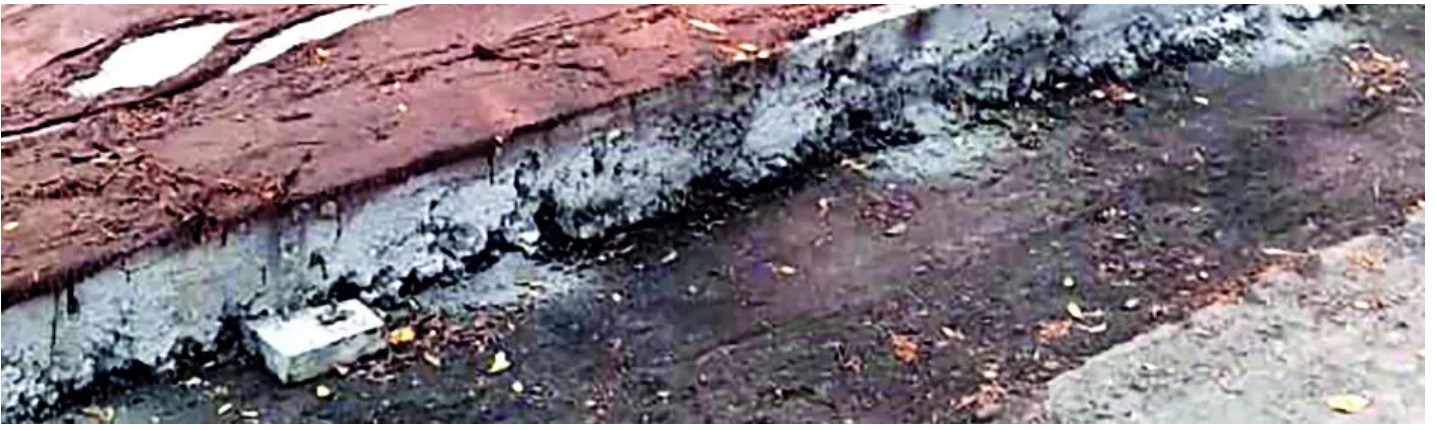
White-topping underway in Malleswaram

When BM reached out to BBMP, the civic body denied any discrepancy. However, when a picture of the ongoing white-topping work was shared, an official said tie bars will be inserted after drilling holes in the slabs. "We are using M40 grade concrete, for which we do not use steel reinforcement. The work is being done the same way everywhere in the city. Tie bars are a small issue. We will drill holes in the slabs and put the tie bars," the official said. "As per Indian Roads Congress guidelines, tie bars are supposed to be put while concreting the slabs to ensure grip. It is done to increase structural strength. It is no showpiece to be drilled in later," added Dr Verma.
