Underground Urban Cavities: Consequences and Identification Through an Integrated Approach

K. Panjami and P. Anbazhagan

Abstract Cities have lots of opportunities due to infrastructure development and modern life. But this modern life comes with other inconvenient packages; the most concerning one is high and frequent traffic jams. This traffic congestion can affect the vehicle speed and can increase the pollutant emissions and fuel consumption. Even though traffic jams result from several factors, the most important one is the road condition. Road conditions are highly dependent on the intactness of the subsurface layers of the pavement. Recently, many cities have encountered a sudden failure of roads because of the formation of cavities and weak subsurface layers in the process of natural and human construction activities. Several such incidents are being reported in India; major events are a metro bus and car plunged into a crater in Chennai city, the collapse of an entire street in Hyderabad, and the natural sinking of wells and houses in the Western Ghats in Kerala and North Karnataka. Such cavities and weak zones are unavoidable in cities; at the same time, proper, timely i

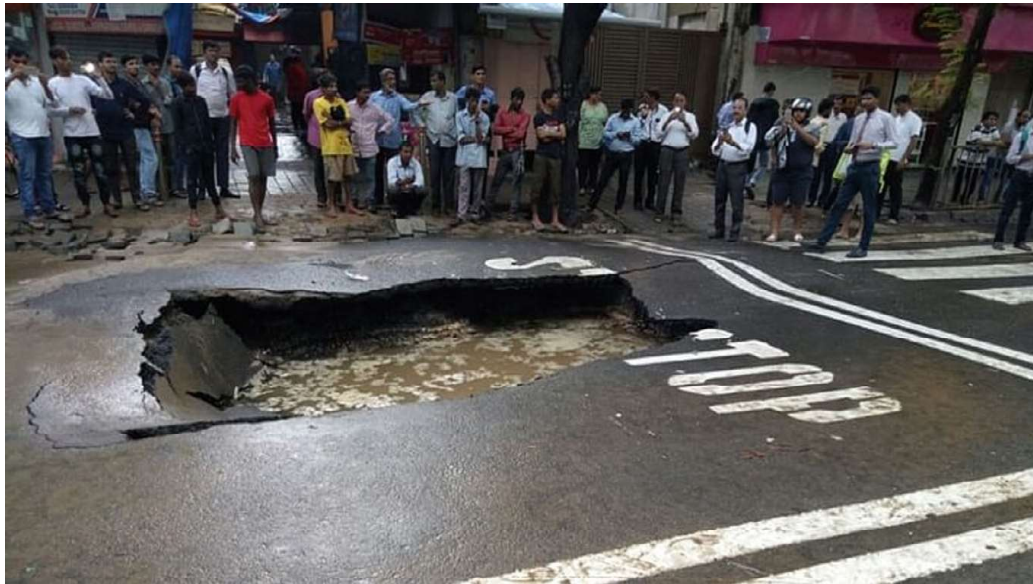
Fig. 1 Road caved in due to water pipe burst at Kalbadevi, Mumbai, Maharashtra (26 June 2018)

new communication line needs to be buried underground, communication companies may employ excavators and laborers who lack expertise in properly compacting the subgrade. After laying communication lines near water supply or sewerage lines, loose soil is often used as a backfill without adequate compaction. Subsequent agencies responsible for overlaying the site with pavement material may neglect the necessary subgrade compaction, resulting in poor pavement performance and, in some cases, catastrophic failure, such as road cave-ins and sinkhole formation [3]. In a few cases, cavity or sinkhole formation has been linked to the post-testing phase of underground water or sewerage lines. The high-pressure conditions generated during testing can lead to leaks, causing the rapid flow of water or sewage at high pressure within the surrounding soil. This flow erodes the neighboring soil, ultimately resulting in the formation of voids. Instances have arisen in areas where historical wells, once used for drinking, household needs, and irrigation, have been subsequently filled or plugged with inadequate materials. Locations of such wells are often poorly documented due to frequent changes in land ownership and usage. Road collapses may be triggered by the gradual transfer of the filled well material due to seepage or fluctuations in the groundwater table. Figure 1 depicts a case of a hole formed in Kalbadevi, Mumbai, Maharashtra due to a water pipe burst.

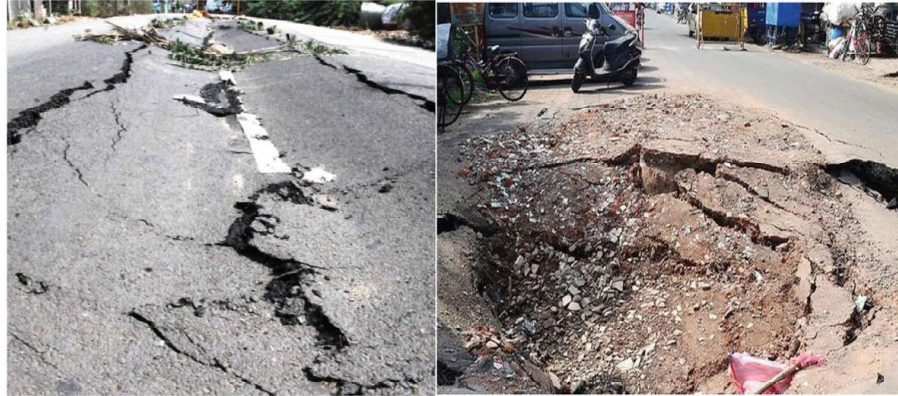
Fig. 2 a Kannapiran Mill Road, Coimbatore (10 May 2016) b MG Road, Kumaran Nagar, Padi, Chennai (03 November 2020)

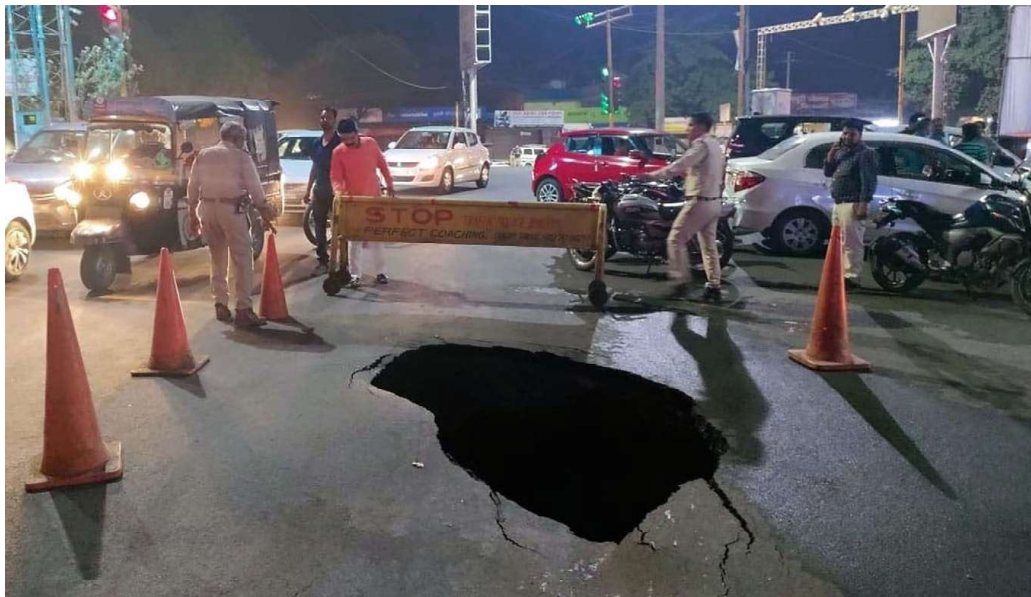
Fig. 3 A 10 feet sinkhole formed in Kolar area; Bhopal due to pipeline burst (01 May 2022)

cave-ins and sinkholes. Instances have been reported from urban areas in which a huge cave was formed all of a sudden. In 2022, there was a massive sinkhole observed in Kolar Road, Bhopal, due to a pipeline burst as shown in Fig. 3. Also, the entire street of Goshmahal in Hyderabad caved in due to an Open drain/nullah covered by concrete slab below the road as shown in Fig. 4. There is a high chance of vehicles to fall into these holes, especially in crowded municipal cities.

leak in the pipe and it was found that cavity propagation underneath in flexible pavements gives surface indications in the form of cracks and settlement while there will not be any surface indication in rigid pavements unless it collapsed suddenly. Table 1 shows that out of 101 cases collected 78% of issues are reported due to unknown leakages in pipelines. 10-foot sinkhole formation incident in Kolar area, Bhopal, due to leakage in an underground drinking water pipeline is a typical example. A huge sinkhole was formed by the gradual erosion of the subsurface and the same is shown in Fig. 3.

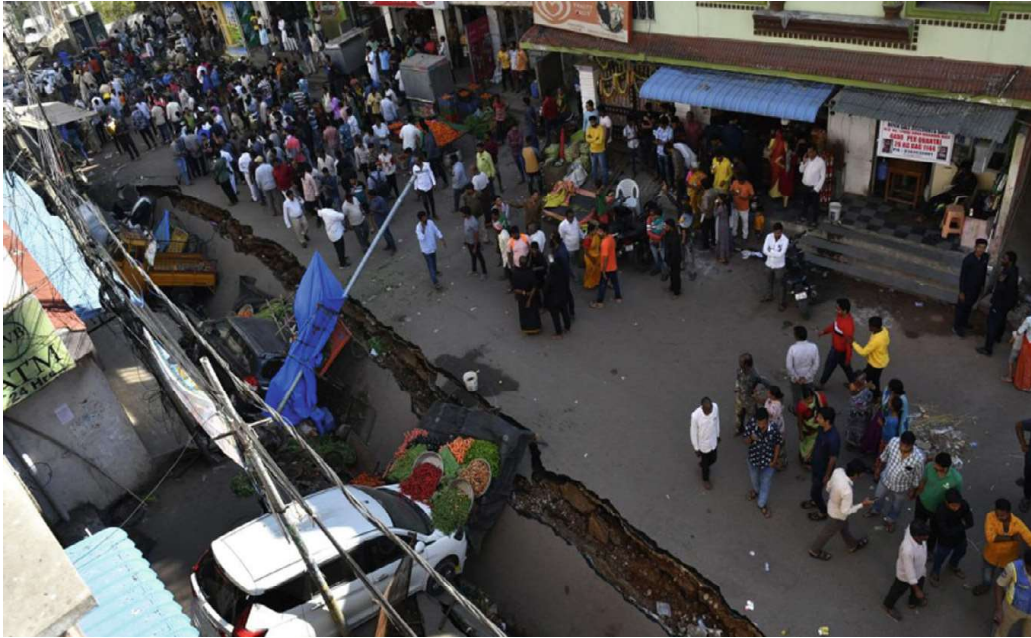
Fig. 4 Road stretch in Goshmahal, Hyderabad caved in due to Open drain/nullah covered by concrete slab below the road

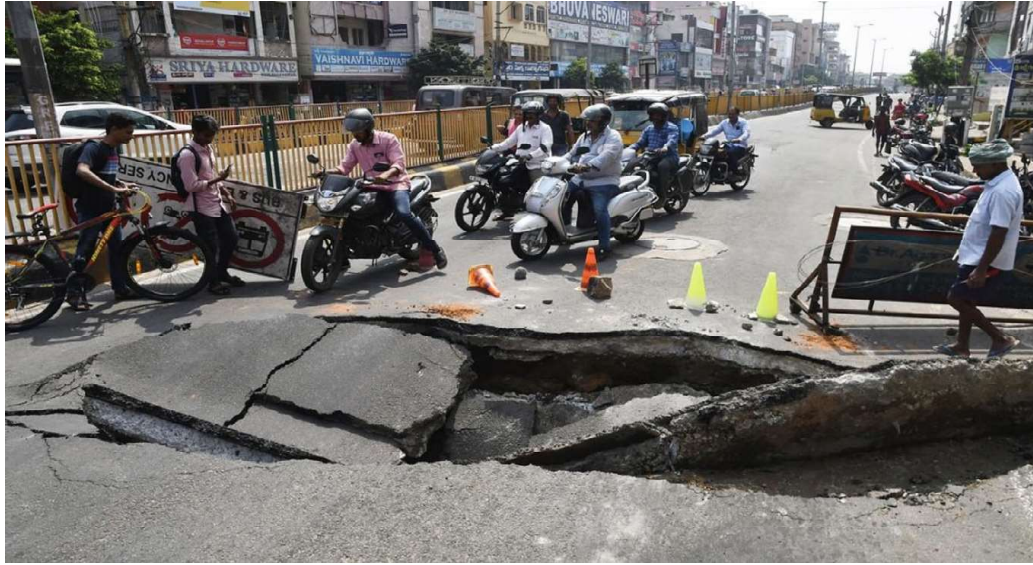
Fig. 5 Barricades being erected to divert traffic near Rama Talkies Junction in Visakhapatnam in October 2022

alligator cracks and subsidence, and these can intensify with traffic load and can lead to subsidence in a faster rate. In turn, once there is a cave-in formed it further affects the operation of smooth traffic flow. Traffic congestion is very common in most of the cities in associating to these kinds of sinkhole incidents. This traffic congestion can influence the average vehicle speed, pollutant emissions, and fuel consumption. Vehicle speed was found consistently decreased with reduction of road width, due to the sinkhole formations. Also, the pollutant emission increases due to the vehicles in traffic jam, which also causes drastic increase in fuel consumption [6]. Figure 5 shows how the sinkhole formed in the middle of the road diverts the traffic and increases the traffic congestion.

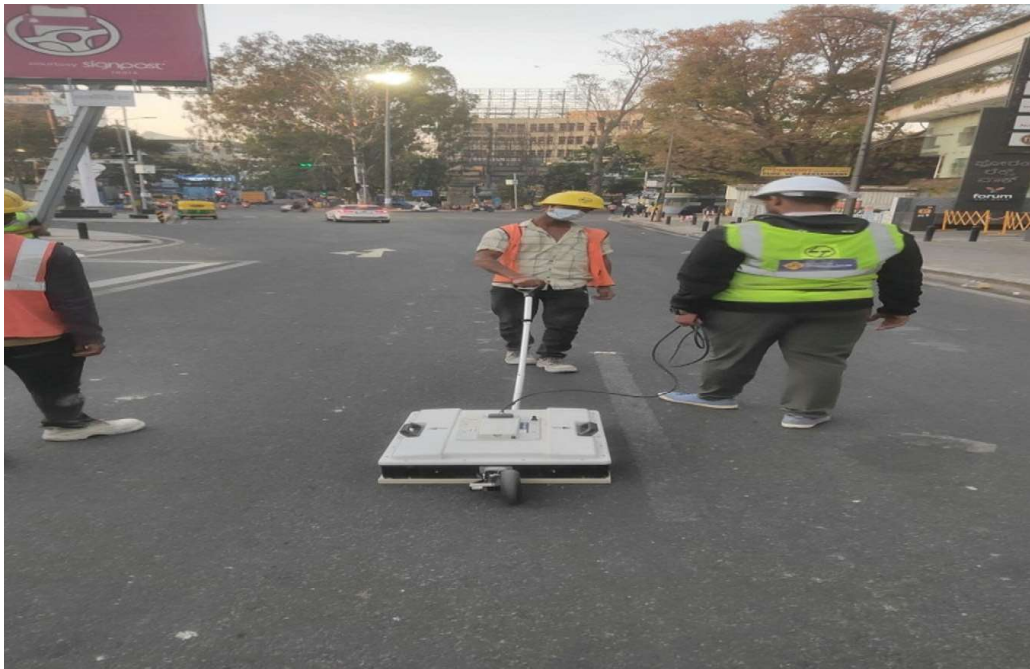
Fig. 6 GPR survey conducted in MG road

lacking fines, cavities, or water pockets, deviate from the surrounding homogeneous conditions. The varied range of geophysical methods facilitates the measurement of contrasts between subsurface structures and the surrounding lithology. To investigate the presence of underground anomalies such as weak zones in urban areas, a survey was conducted in Bengaluru MG road and the results are presented in this section. A comprehensive survey utilizing Ground Penetrating Radar (GPR) and Multichannel Analysis of Surface Waves (MASW) was conducted to assess the effectiveness of early detection of subsurface problems in the pavement. The equipment employed in this investigation was the Mala GX GPR, produced by Mala Geoscience. This apparatus consisted of bi-static antennas with shielding, specifically 450 MHz and 750 MHz ground-coupled antennas, a GPR acquisition system, interconnecting cables, and an odometer as shown in Fig. 6. Also MASW survey employed with a 12-channel seismograph fitted with geophones operating at a frequency of 4.5 Hz was used for the survey, which is shown in Fig. 7.
