Study of Techno-Legal Aspects of Accident Site Investigation—A Case Study from Bengaluru

Ashish Verma, P. Anbazhagan, and R. Babitha

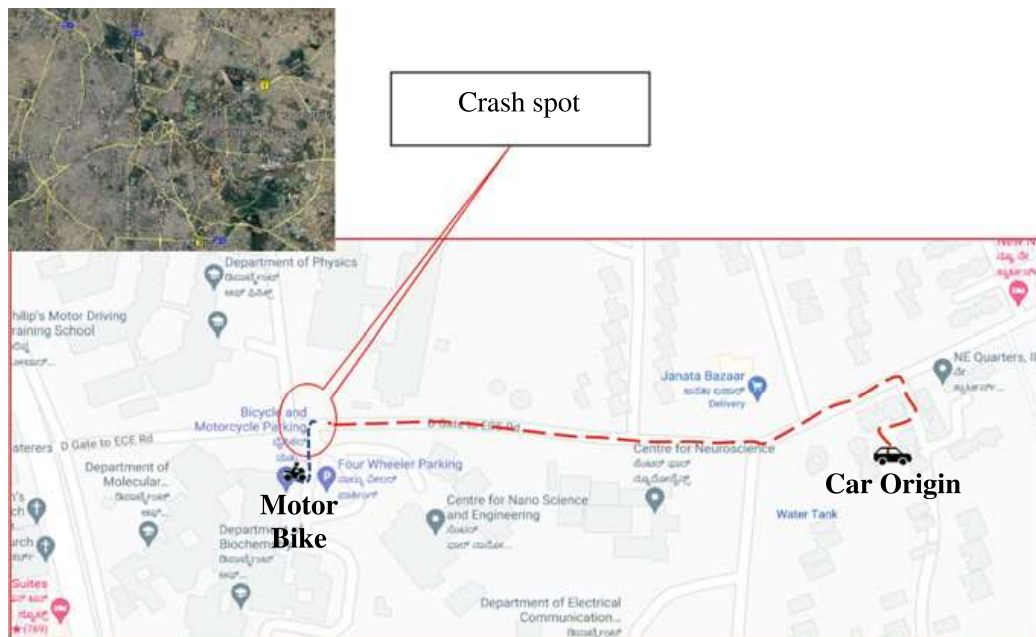
Fig. 1 IISc map showing the car moving path and the crash location (Figure prepared using Google Maps)

left the crash spot. Later bike was moved to the parking area. Car was inspected by authorized service engineer and he suggested to move the car through tow vehicle and after few hours the car was towed to the nearest service station. Vehicle travel distance from origin spot is shown in Fig. 1, and it can be seen that car had crossed four junctions and about 270 m after the last junction point (Janatha Bazaar Circle). The bike just had one turn and approached, reaching gate and road junction after passing a steep-sloped ramp.
