Reconnaissance report on geotechnical effects and structural damage caused by the 3 January 2017 Tripura earthquake, India

P. Anbazhagan¹ · Kunjari Mog¹ · K. S. Nanjunda Rao¹ · N. Siddharth Prabhu¹ · Ayush Agarwal¹ · G. R. Reddy² · Sima Ghosh³ · Malay Kr. Deb⁴ · Saurabh Baruah⁵ · Sarat Kr. Das⁶

Received: 16 August 2018 / Accepted: 30 July 2019 / Published online: 8 August 2019
© Springer Nature B.V. 2019

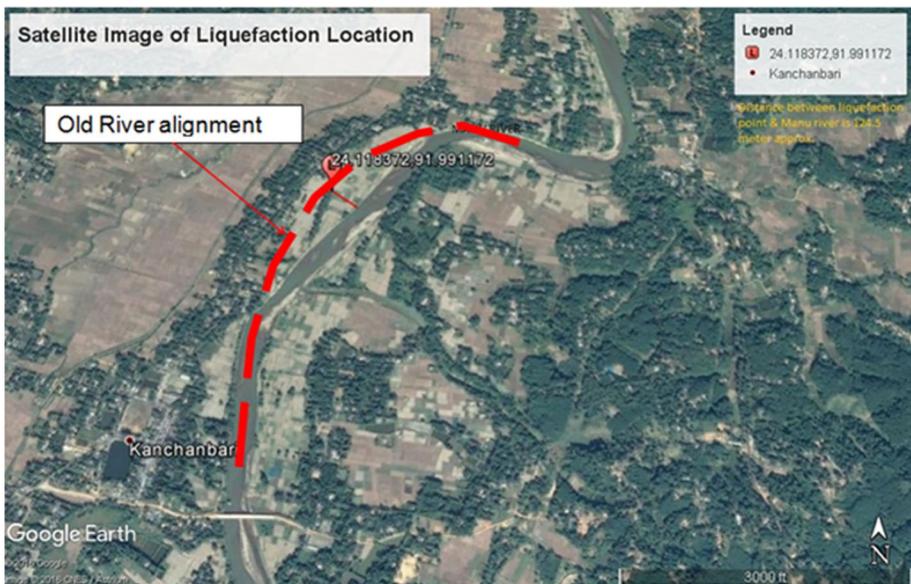
Fig. 5 Satellite image of the liquefaction area located at Kanchanbari, Kumarghat in Unakoti District, Tripura, India. *Source:* Google earth

50–60 years ago the river was flowing through the area that is presently being used as agricultural land (see Fig. 5). Thus, loose, river deposited soil has been converted into agricultural land, which was liquefied during the earthquake. The present meandering of the river in the figure may evidently support that statement. The presence of loose, saturated sandy and silty soil with very little clay (which is highly susceptible to liquefaction) and existence of water table at a depth of 1.5–2.5 m depth may have suitably led to liquefaction for this moderate magnitude event in the area.

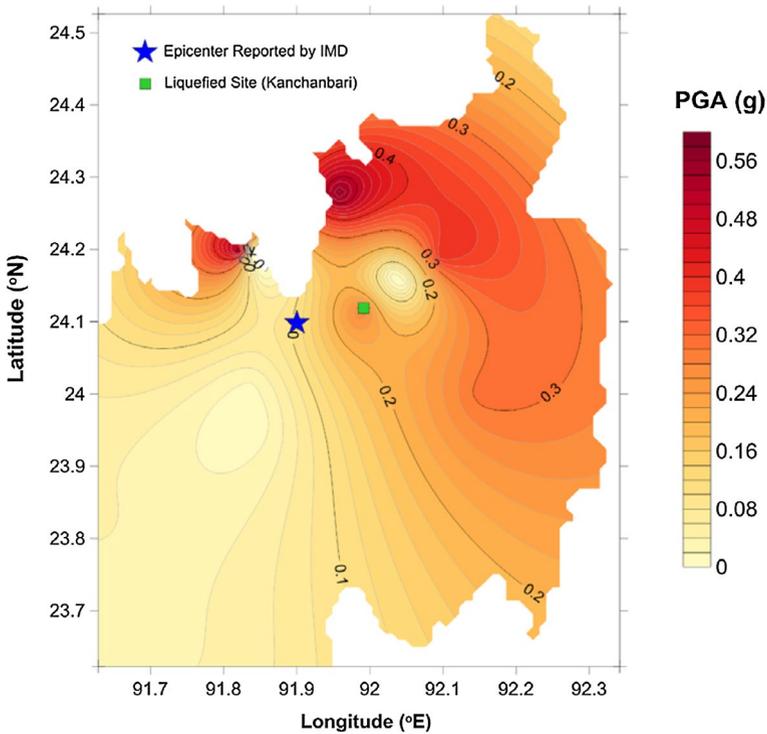
Figure 22 shows the surface PGA distribution near the epicenter of the event estimated using the expression suggested by Anbazhagan et al. (2016) as discussed in the previous section. The estimated PGA value varies from 0.05 g to a maximum of about 0.57 g and at the liquefied site (Kanchanbari, Kumarghat, Tripura), it goes up to 0.28 g which is sufficient to cause liquefaction for loosely deposited sandy soil sites. It can be seen from Fig. 22 that northern part of the state bordering Bangladesh has a higher value of PGA as opposed to the central Tripura where it is in the range of 0.05–0.1 g. Though the observed value is based on some assumptions or obtained through the regional GMPE's, it can be used as preliminary risk assessments (Aydan 2015a, b). However, as the attenuation relations, with

Fig. 22 Surface PGA near epicentral area and liquefaction site for 3 January 2017 Manu earthquake, Tripura

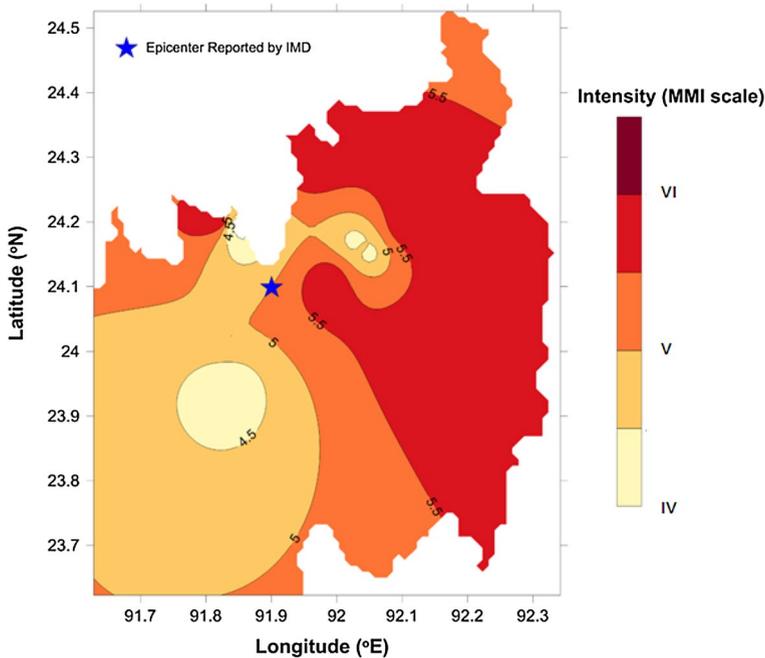
Figure 23 presents the intensity map in Modified Mercalli Intensity (MMI) scale, which is generated using the data collected by the IISc team during the reconnaissance survey in the earthquake affected area. An intensity of V is reported near the epicenter of the earthquake which is sufficient to cause structural damage. It can be observed from Fig. 23 that the intensity keeps on increasing toward the north east of the state reaching a maximum of VI, whereas in the central part of the state it is seen to have intensity values ranging from IV to V. This preliminary estimation of surface PGA and intensity map for the 3 January 2017 Manu earthquake highlights the need for site-specific amplification and liquefaction estimation in Tripura to account them for the design of new buildings, infrastructure, etc. and also to retrofit the old structures to minimize catastrophic losses in case of any future event.

Fig. 23 Modified Mercalli Intensity (MMI) map created by damages reported in this study
