# CURRENT SCIENCE

## Field investigation of the 30 September 1993 earthquake in Maharashtra

R. N. Iyengar\*, C. S. Manohar and O. R. Jaiswal

**An engineering field study of the 30 September Marathwada earthquake is reported. The study covered Osmanabad, Latur, Sholapur, Bijapur, Gulbarga and Bidar districts. The level of ground acceleration was estimated based on tilting of free standing objects. The study shows that the epicentral intensity has been VIII on the UNESCO scale. The horizontal ground acceleration near the epicentre has been estimated to be about 0.2 g.**

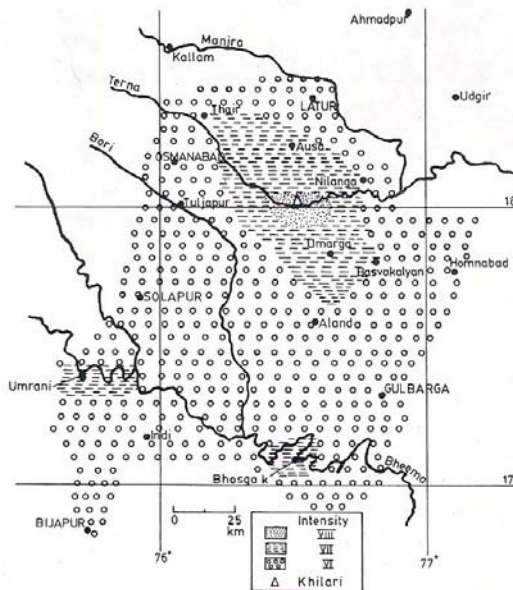
Figure 1b. Damage intensity map on the UN scale.

of the earthquake at a particular location. This depends not only on the site and earthquake source parameters, but also on the construction quality prevailing in the region. Presently, there are two widely accepted intensity scales, namely, the modified Mercalli intensity (MMI) scale and the UNESCO intensity scale<sup>3</sup> (same as MSK scale). On both these scales there are twelve ratings. For an earthquake of magnitude 6 to 7, the epicentral intensity can be expected to be in the range of VII–X on either of the above scales<sup>4</sup>. Of the two scales, the UNESCO scale is more precise and measures the damage to buildings on a finer scale. This scale has been adopted in the present study. The UNESCO scale classifies buildings into three groups, measures damage levels on five grades and quantifies damage ratios at three percentages. On the basis of all these three informations and a few others, the intensities are worked out (Table 1). The intensity map, according to the present field study, is shown in Figure 1*b*. The epicentral intensity is estimated to be VIII. This drops by one unit beyond
