## Forensic investigation of earthquake induced failures during Sikkim 2011 earthquake, India

Anbazhagan P<sup>i)</sup> and Murali Krishna A<sup>ii)</sup>

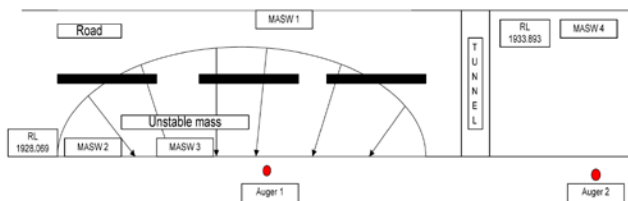
Fig. 4 Investigations location at Bulbulay road, Gangtok

This particular site was located at the Western bay pass, Bulbulay Road, Gangtok (1 km away from Tashi view point towards Ganeshtok). Circular slide inducing cracks, settlement on the road and lateral movement of slope were observed. Incipient landslide condition. Field Photo is shown in Figure 3 and MASW and GPR survey lines are shown in Figure 4. MASW study shows that about 0.5 to 1.0 dense layer with SWV of

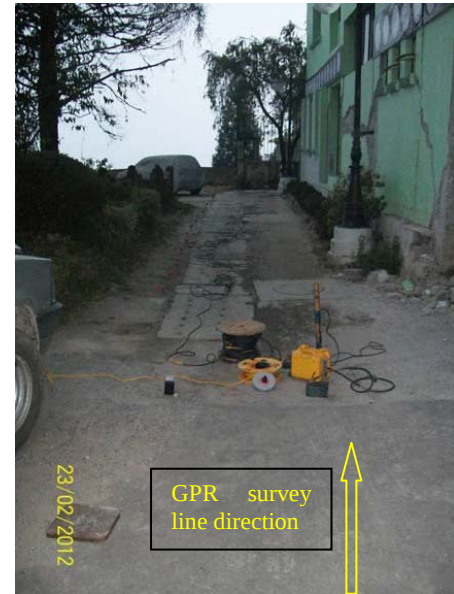
Fig. 9 GPR and MASW survey close to secretariat building

Old Secretariat building, Gangtok, Sikkim is located at 27.32463°N , 88.61430° E, 1701 m elevation. Extensive structural damage of the 5 storied framed structure with masonry infill was observed. The earthquake resulted in a severe damage in the [part of the Secretariat building resulting in cracking of the structural members. It can be highlighted that one part i.e back side of the building damaged more when compared front side building (Fig 8). This building is structurally sound and designed according to seismic code. A GPR survey carried out from front side back side to get subsurface soil layer and rock depth. MASW survey carried out close to back side as shown in Fig 9.

SWV velocity profile close to secretariat building is shown in Figure 2. Very loose material having shear wave velocity less than 180 m/s found up to 3 m and followed by medium dense soil with SWV of 320 m/s up to 10 m and followed by hard/rock layer. GPR radargram using a low frequency antenna of 25 MHz is shown in Fig 10.
