# Despite IISc study in 2019 flagging design flaw in Yeshwantpur flyover, no corrective measures implemented

Ashish Verma, Department of Civil Engineering, IISc, who led the study in 2019, said they had recommended for crash barriers to be increased to at least 2 m, among a host of other recommendations

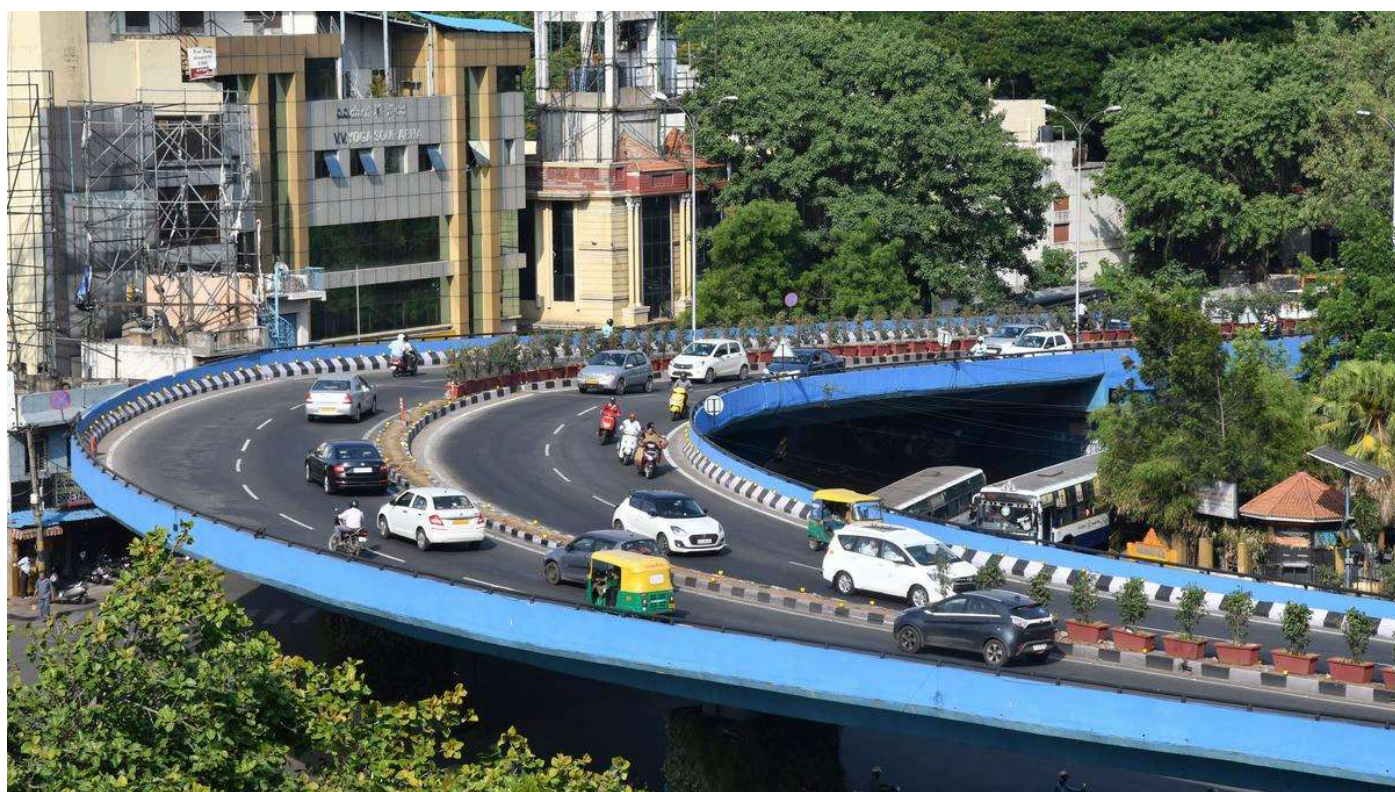
Pandith Deendayal Upadhyaya Flyover (Yeshwantpur flyover) in Bengaluru. According to IISc experts, the curve is very sharp (almost 90 degrees), which makes heavy vehicles vulnerable to accidents. | Photo Credit: Bhagya Prakash K

IISc had concluded that there was flyover design was flawed. “This is owing to the poor design of the horizontal curvature. The horizontal curve is very sharp (almost 90 degrees turn), which makes heavy vehicles vulnerable to accidents. With increase in speed of the vehicles on the flyover, the centrifugal force acting on the vehicles increases by many folds, throwing the vehicle off the flyover,” the study had then said.

Ashish Verma, Department of Civil Engineering, IISc, who led the study in 2019, said they had recommended for crash barriers to be increased to at least 2 m, among a host of other recommendations. However, Mr. Verma said apart from installing rumblers at either ends of the flyover, no other corrective measures were taken.

In the accident that occurred early on Tuesday, the car that was overspeeding lost control exactly at the steep curve, hit the road median and a bike coming on the opposite lane, flew over the existing crash barrier, which is less than 1 m, and fell to the ground. Had the crash barrier been higher, the car may have not fallen to the road below.
